# Isle of Wight Industrial Archaeology Society

### Survey of woodland between Fort Victoria and Cliff End Battery

Requested by Countryside Services, Isle of Wight Council

June 2007

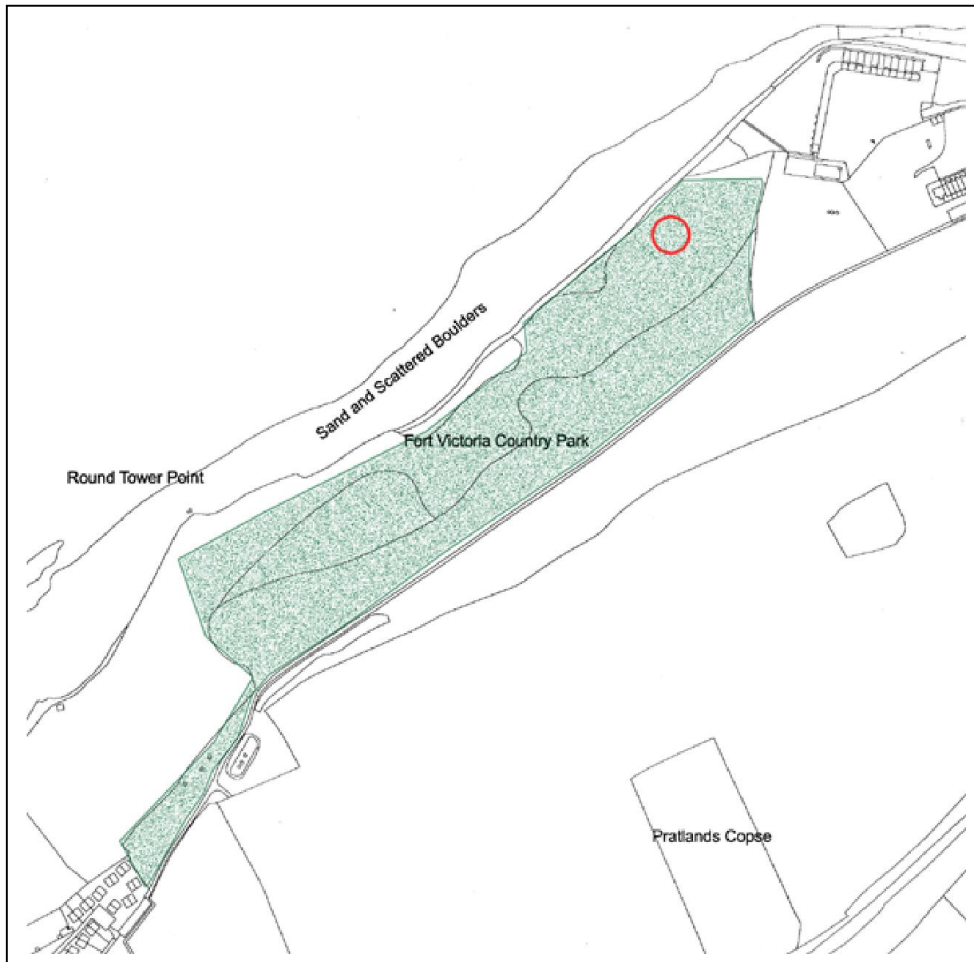
### Area Surveyed

Circled area worthy of metal detecting

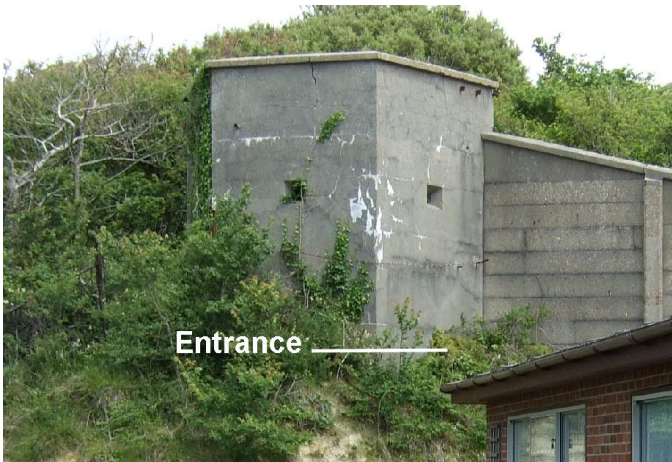
Essentially this is a lookout above a pillbox. Six sided, with the lower section having a firing window in each side. There are some minor cracks and superficial damage but it is generally in good condition. Construction is by rendered preformed concrete sections, probably reinforced. The floor supporting the lookout is reinforced concrete.

Western view

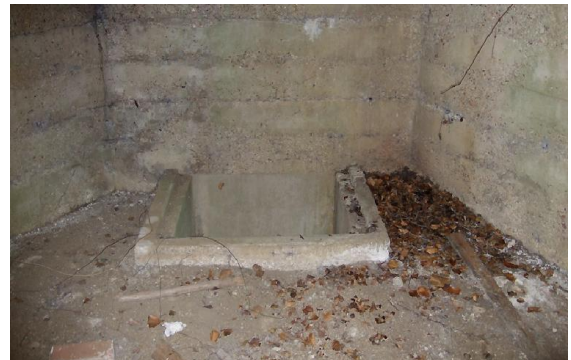
Internal entrance at base of gunner's section

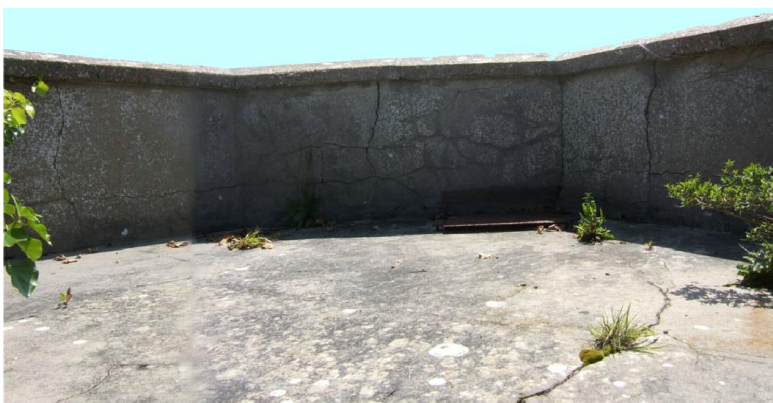
The top lookout section is around a metre high, so the lookout would presumably be sitting down. There is no cover for the lookout as part of the structure. There is a small hatch in the lookout floor against the W wall. It looks a little small for access so it might have been for communication. Another larger hatch at the base of the gunner's SW wall is the entrance. The external entrance is now overgrown. A brief clearance revealed it has been bricked up. There are ladder fixings on the wall so the lookout could have entered by this means. The walls are 2.2m wide. The top of the external entrance is 3.6m from the top of the tower. The absolute base cannot be determined.

Lookout section showing hatch against W wall

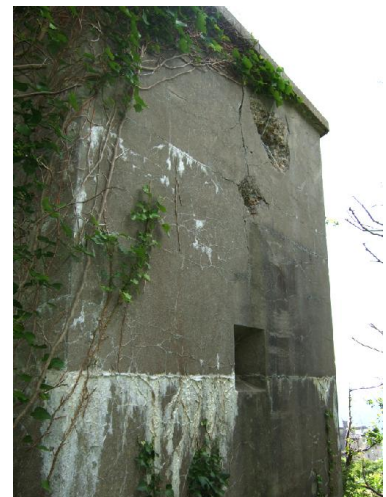
Eastern wall

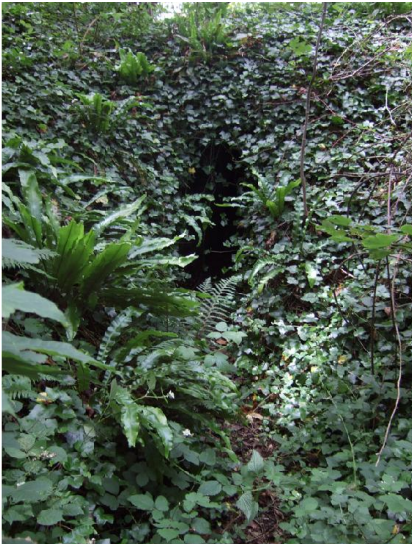
A standard arrow shaped design, mostly sunk below ground level. Brick built with a concrete gun platform. Although overgrown, it is in good condition. The heavy gauge corrugated iron roof has slipped down at the front, obscuring the firing window, but this should be easy to rectify.

Entrance

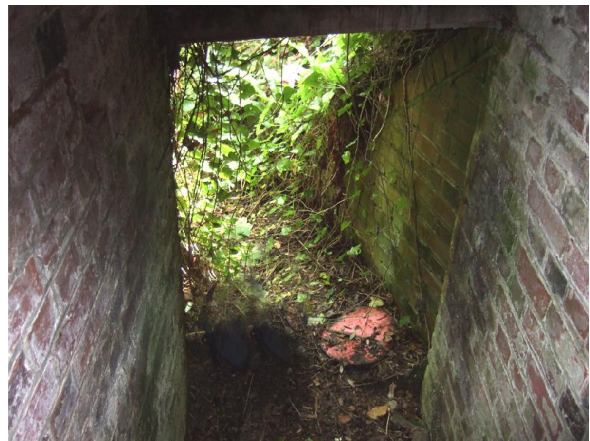
A covered passage leads to an internal space 1.8m wide and 1.55m deep. It would only accommodate the gunner. There is some evidence of fixings in the brickwork on either side of the gun platform. These suggest a framework to support the ammunition belt, as required for the Vickers machine gun, although it doesn't rule out use of the Lewis barrel gun. The firing window is 90cm wide.

Passage

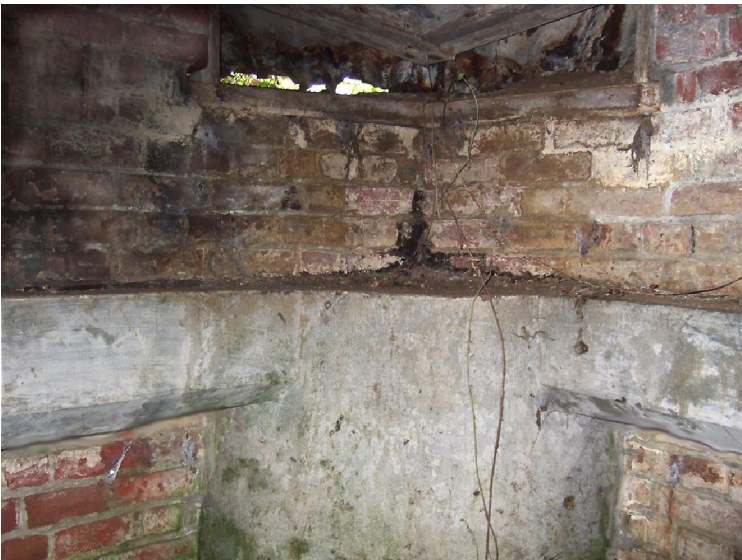
Gun platform with firing window above

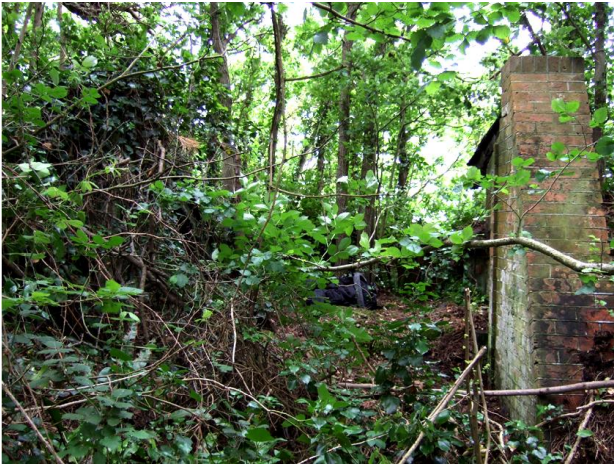
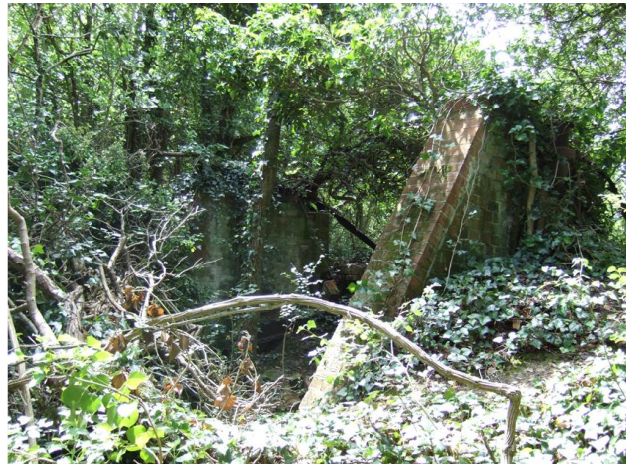
These are identical structures, both in a heavily dilapidated and overgrown condition, leaving some aspects of their design a little unclear. The western cell is in slightly better condition.

Rear view of the cells. Both have overgrown walls on the left. Only the western cell (left) has one complete side reasonably intact.

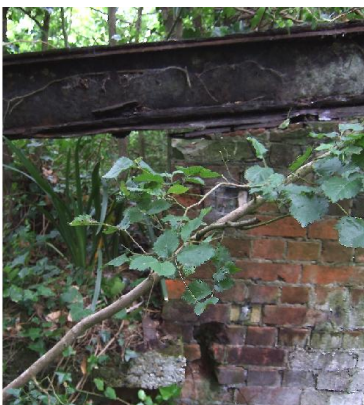
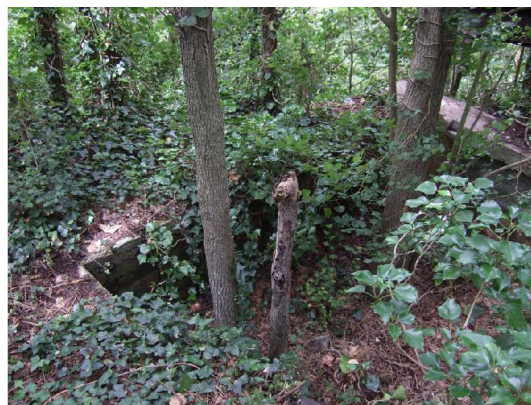
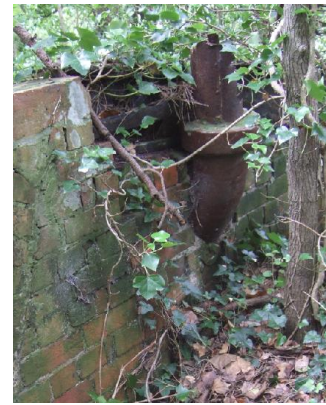
Girder (left) running off the end of the rear section into space, above the lower front section (centre). Flue outlet (right) for a stove.

The rear has buttresses rising to roof level; thereafter walls supported sloping iron girders that extended beyond the supporting wall of the rear section to run the full length of the building, over the lower front section. Cross members carried a concrete roof. The roof is now collapsed to the floor in both cells. Fixings on the inside of the walls suggest a timber or metal framed rear entrance.

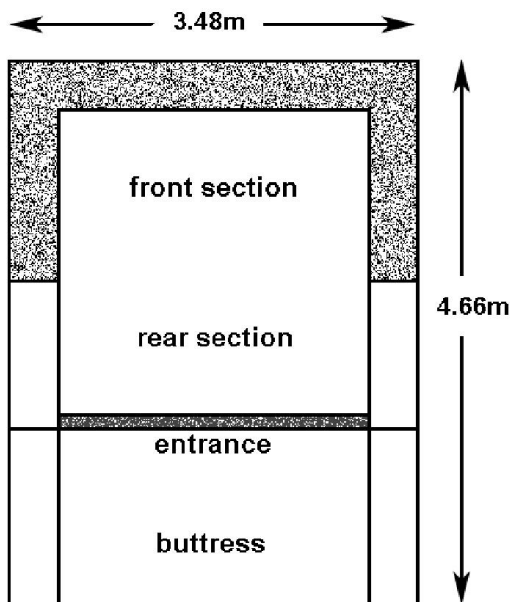
**Basic Plan View**

The walls are substantial 46cm brickwork, including a cavity with airbricks. The design has distinctly different front (seaward) and rear sections.

The front has the brickwork continuing at waist level, topped with a concrete surround, above which is now open space. The roof appears to have had no permanent structural support at the front.

There is evidence for a tap water supply and a flue outlet for a stove. Height from foundations to the highest point is 2.53m

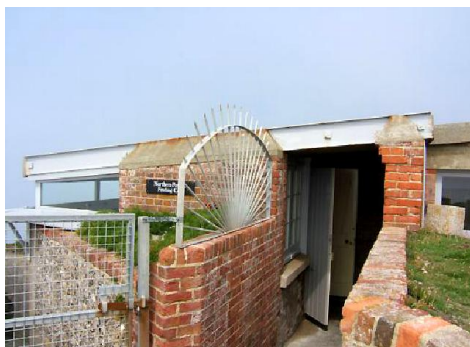
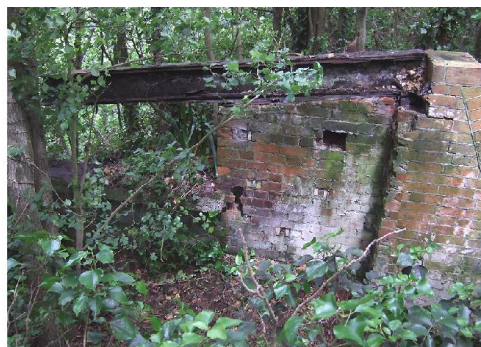
The cavity wall implies a need to control temperature and, perhaps, humidity, so there must have been some sort of shuttering or window framing at the front. Fortunately there are two existing examples of position finding cells at the Needles Battery. One of these shows a similar design.

The Needles example, at left, is an extension and has a side passage leading to a rear entrance, whereas the Cliff End example, at right, was simply faced with the rear entrance. Otherwise the basic design is not dissimilar.

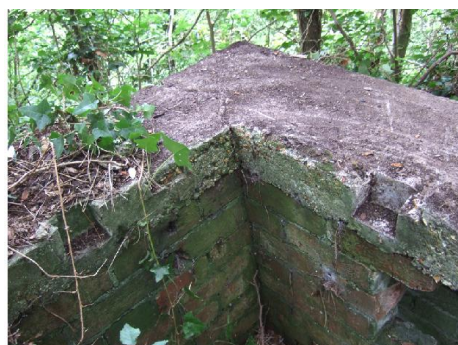
One significant difference between the two designs is the manner in which the front framework is incorporated. At the Needles the window framework is a permanent fixture. The Cliff End cells have no evidence of similar fittings. The concrete surround, at left, shows no sign of ever having framework sitting directly on it. The only evidence of fittings are occasional slots on the inside, like the two shown. This may indicate a requirement to remove the whole upper front section at times, giving a clear 180-degree view.

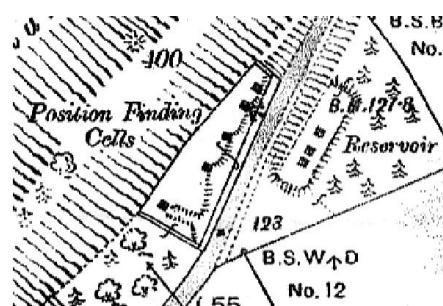
The lack of any research evidence means the Cliff End cells cannot be precisely dated. There are five cells shown on the 1908 OS map, at right. It is the eastern three that have fallen into the undercliff. Position finding cells are said to have originated from the late 1870s, presumably through the development of longer range guns. The earliest possible date for the Cliff End cells is probably around 1885, and they may well be later. One of the girders carries the maker's name, Dorman Long. This company was established in 1875 but their early work was confined to shipbuilding. The Needles cells were built in 1901.
