## A Survey of Railway Track on Pre-Grouping Island Railway Companies

by Richard Brimson

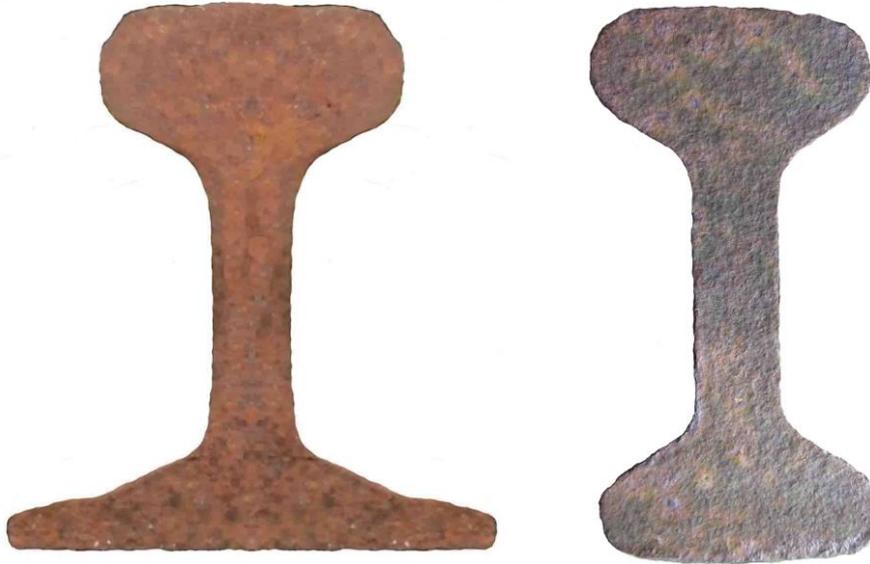
*Above: Cross-sections of typical flat bottom and double headed rails as used by island companies.*

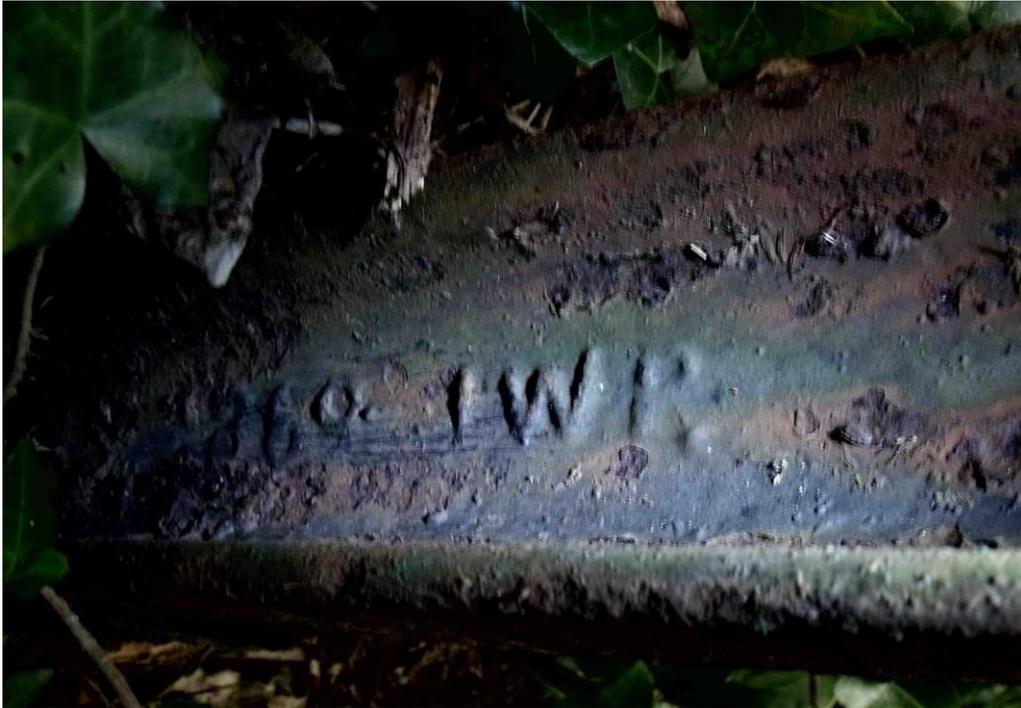
*Just visible on this rail fence post is the date 1869 and IWR; surely a valuable piece Isle of Wight industrial history.*

One piece of rail does exist though, difficult to access, hence the poor quality photo (below) it is from the Isle of Wight Railway Co. and rolled only five years after the opening of the line; it's dated 1869. At this time IWR used only flat bottom wrought iron rail and during the first few years IWR bought rail from the Governor & Company of Copper Miners in England, this company ceased along with so many other iron works once steel became generally available. By the mid-1870's IWR were seeking quotes for steel rails from Siemens Landore and Ebbw Vale, but still had to purchase iron rails from the Governor company due to lack of funds.

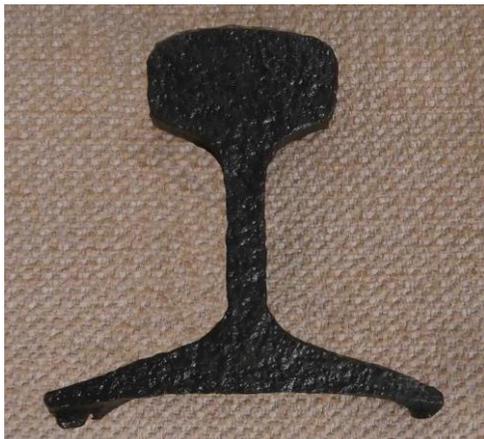
*Possibly the only piece of FY&N Blaenavon rail existing, the foot is 4 1/2" wide, 4" high. The end of a length of rail was trimmed either because of the damage to the foot in this case or to fit the rail into the existing line to allow the correct expansion gap.*

Another identifiable piece of rail exists, but not from the brand mark as it's only half an inch thick, but from the circumstances of its location. It was found among a dump of smashed fixings on the Freshwater line thrown down an embankment after track adjustment well over a hundred years ago and a slice of rail was cut probably to insert the rail into the line to enable the correct expansion gap, it would not have been cut off during dismantling the line. The entire steel rail for the line was purchased in 1887 from the Blaenavon company in south Wales,

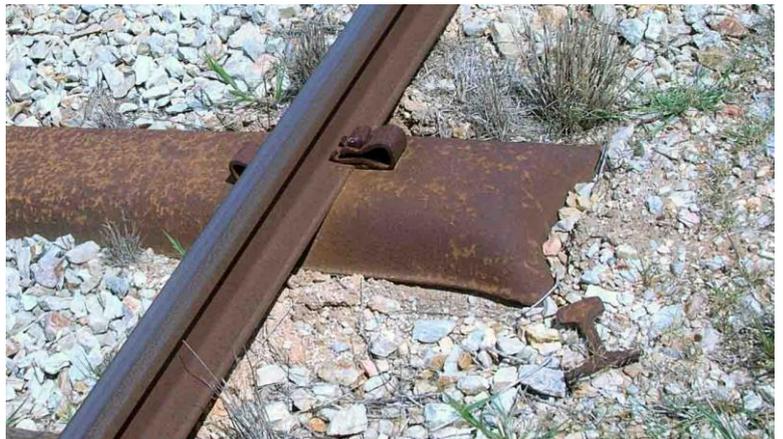
*Similar to the FY&N piece (bottom right) - this rail off-cut was similarly found discarded on the track-bed at Darke Peak on the Eyre Peninsula in South Australia, probably cut off for the same reason*

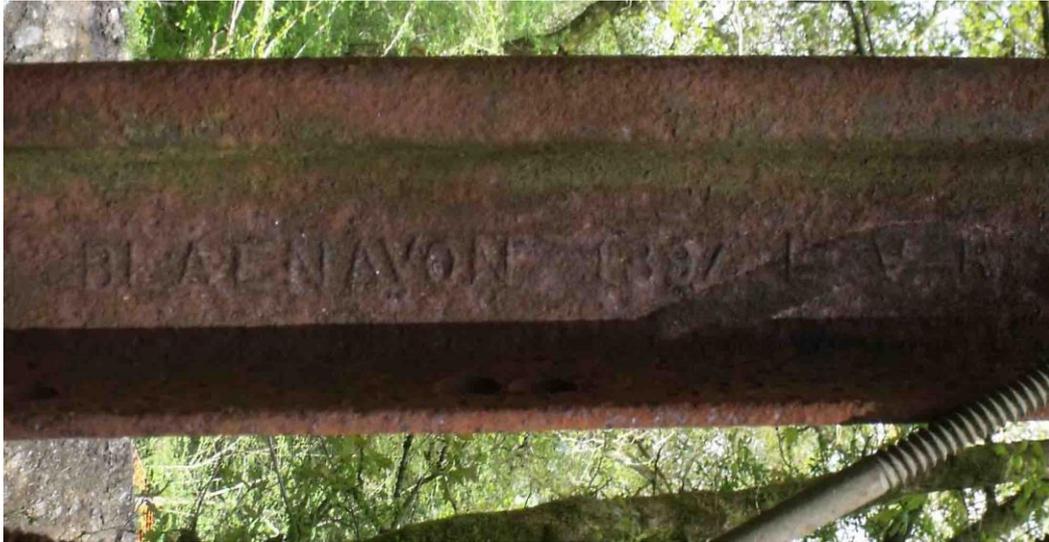
*The FY&N rail would have looked similar to this piece of Blaenavon rail rolled in 1897 for the Lambourn Valley Light Railway (L.V.R.) now a fence post photographed in Devon. The Lambourn line opened in 1898.*

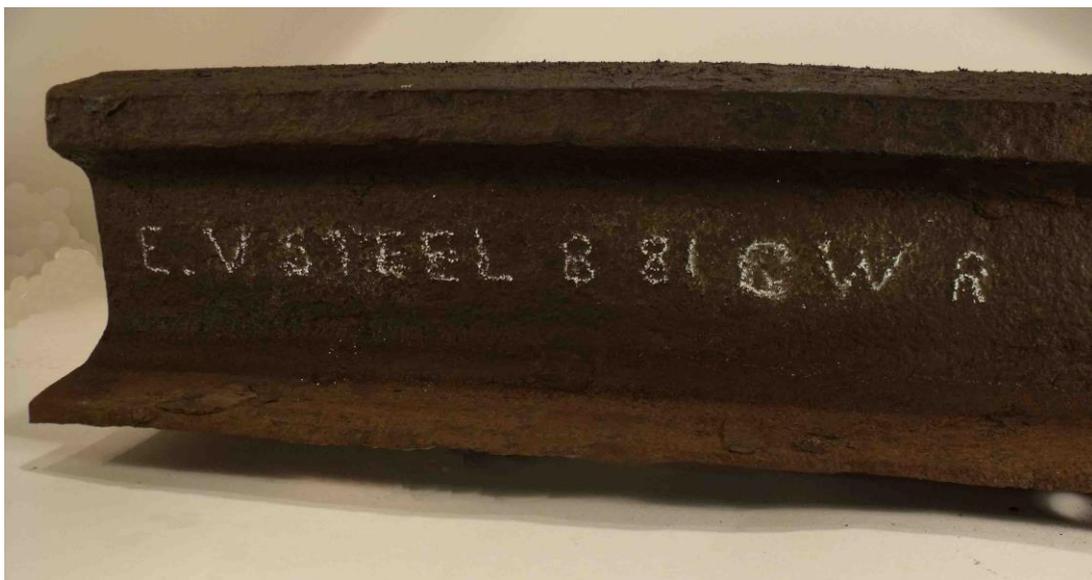
*The Sandown piece of rail with brand mark roughly highlighted with chalk.*

Another piece of flat bottomed rail has been found, this time on the Newport to Sandown line in the River Medina which runs alongside. It was encrusted in rust and gravel and must have laid there for quite a time and once the canker was hammered away a brand mark was revealed: "E.V." (from the Ebbw Vale Iron & Steel works in south Wales) "Steel" (Steel rail was branded to distinguish it from iron), it was

rolled in month “8” (August) year “81” (1881) for the “G.W.R.” (Great Western Railway) What could account for GWR rail being on the island? The island’s railways had no connection with the GWR even when under the control of SR or even British Railways (BR) that could account for this rail being here. The date 1881 puts it with the I.W. Newport Junction Railway which although it had opened from Sandown to Shide in 1875, the Shide to Newport wasn’t opened until 1879, in 1878 the company had applied to the Ebbw Vale company to quote for 25 tons of rail, probably to complete the Shide to Newport section using steel rails, so the IWNJ had traded with E.V. In 1880 the manager of the IWNJ reported that the original iron rails were wearing out quickly and in May 1881 the company needed to replace rails on the Merstone to Blackwater section, 25 tons were required and were looking to replace the worn iron rails with steel, but the company was strapped for funds, however, in June they ordered 20 tons of “*slightly defective rails*” from Green & Burleigh, a railway materials wholesaler and in November the company ordered a further 20 tons. It seems quite likely that the found rail was originally ordered from Ebbw Vale works by the GWR which was a large wealthy company that would not need to use imperfect rail on their network and rejected it, hence the Ebbw Vale company sold the order on to an intermediary such as Green & Burleigh as ‘partly defective rail’ who then sold the rail on to the IWNJ for which it was presumably ‘safe’ enough for their requirements. An off-cut somehow ended up in the river Medina. The rail is worn and corroded and was probably 75 pound/yard; rail size is still graded by weight; pounds per yard, the two batches 20 and 25 tons of 75lb rail would lay about 700 yards of track, not much of a replacement programme! By July 1887 IWCR was formed and the new company continued to buy ‘slightly defective rails’ up till 1889, this time directly from Ebbw Vale, but it is notable that in October 1890 it was recorded that 50 tons of “*perfect*” steel rails were purchased; the financial situation had obviously improved. At the end of 1887 IWCR were offered 300 tons of steel rails ‘*drilled to pattern*’ presumably the company had agreed a standard size of rail across the three former companies, later, in 1892 IWCR obtained quotes from seven different suppliers for 67lb rail and asked to get quotes for 69lb rail which illustrates the variety of rail available. Flat bottom rail often had the base flange punched or drilled for bolting through to the sleepers; some times just one hole either side at each end and others for the whole length of the rail hence the rail ‘pattern’ as the drilling would be done by the supplier to the customer’s requirement.

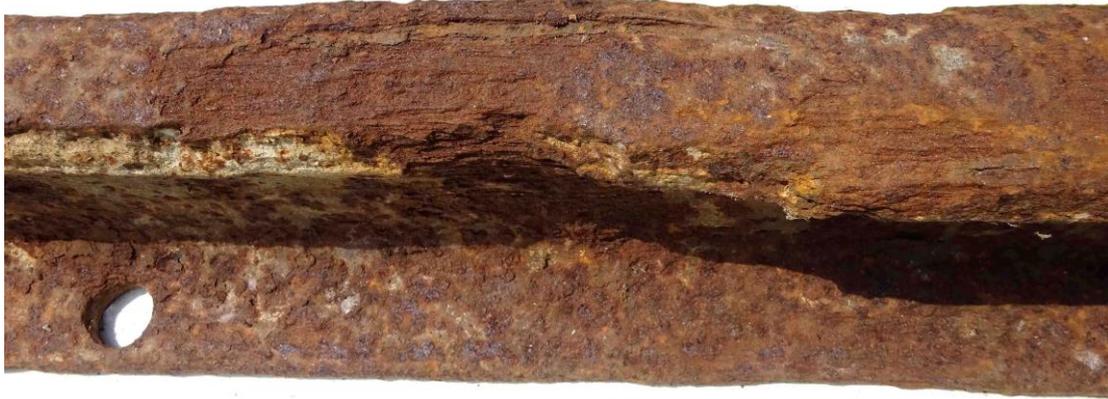
*A close-up of a section of worn iron flat bottom rail recovered from a siding showing the fibrous nature of the material, once the relatively hard surface is worn away the body of the rail quickly breaks up, half of the rail table has actually broken off on the left. Steel is far tougher and more homogeneous than iron, it being more crystalline in structure so it wears evenly and will give good service for much longer even when worn. The hole in the foot is for a through bolt near the rail end the rest of the rail would be 'dog spiked'.*

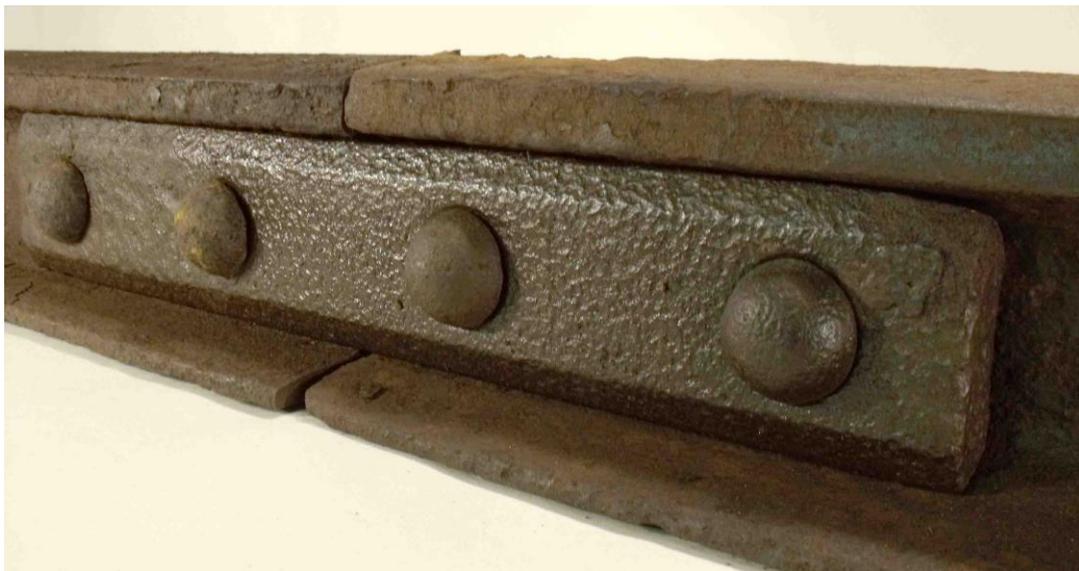
*Above: a typical fishplate shown installed on some flat bottomed IWCR style flat bottomed rail viewed as from inside the '4 foot' as they would have looked on most of the island's railway lines.*

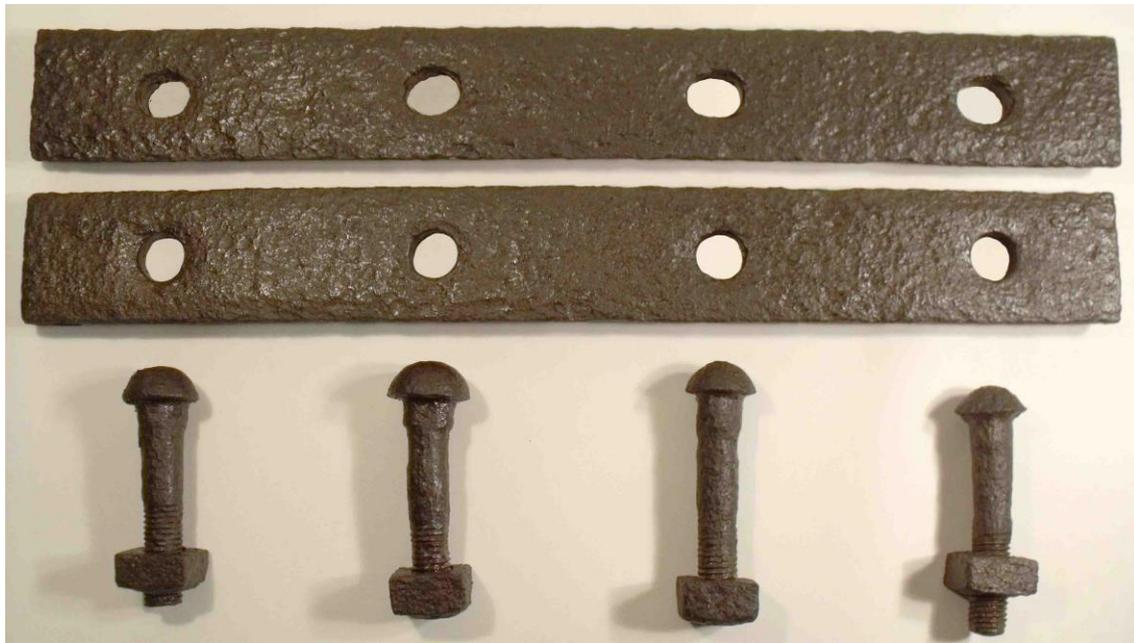
*Above: a matched pair of FY&N fishplates with a set of four oval necked fish bolts and nuts. The upper plate with oval holes would be fitted inside the track, the lower plate with circular clearance holes outside the rails where the nuts are fitted.*

this time were made to accept 'square necked' fish bolts, however the FY&N used 'oval' necked bolts, what the advantage was isn't clear, but the plates themselves are fairly light so cost might have been a factor.

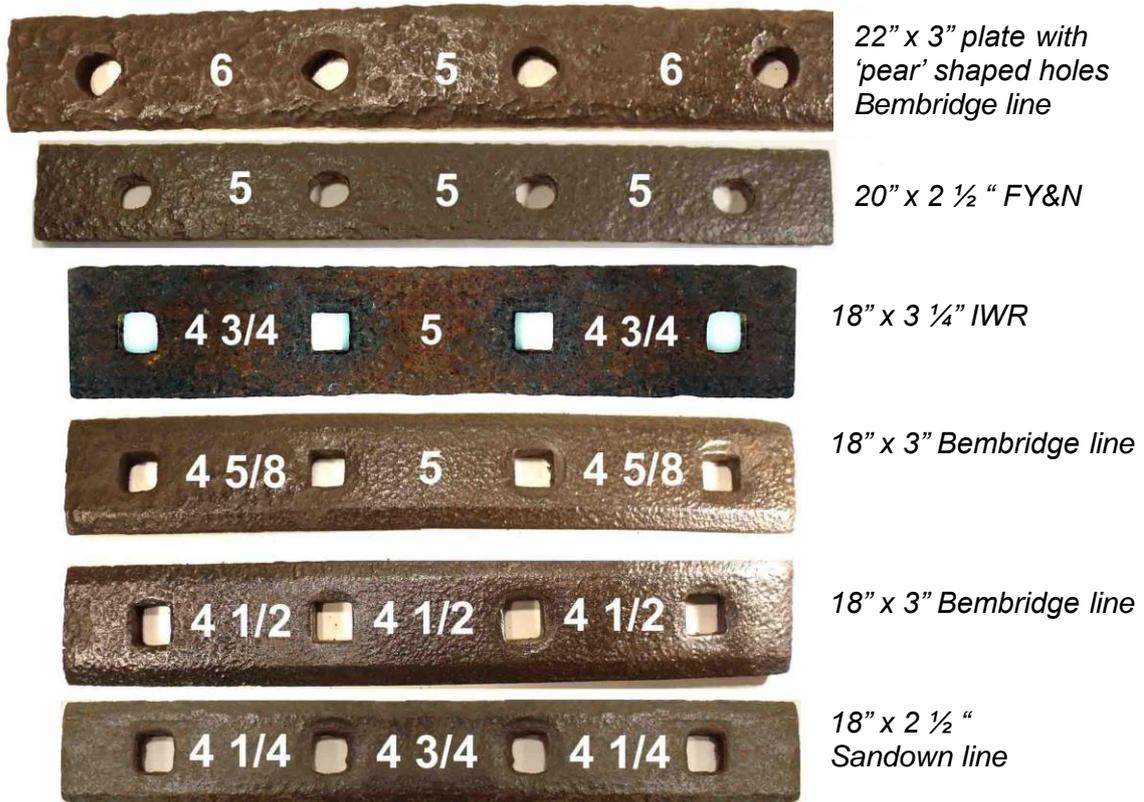
*Dimensions of plates and hole spacing in this small selection collected on the island illustrate the variety of rail joints pre-grouping railway companies worked with.*

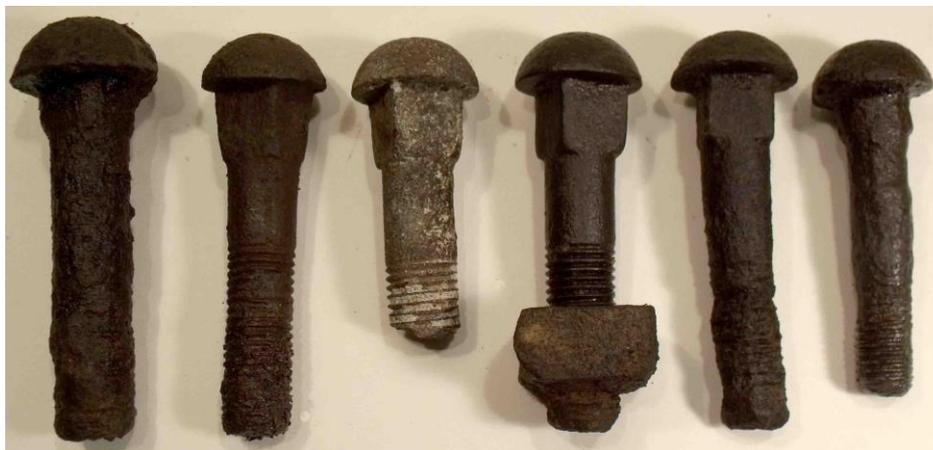
*A sample of square necked fish bolts with a lighter FY&N oval bolt on the right*

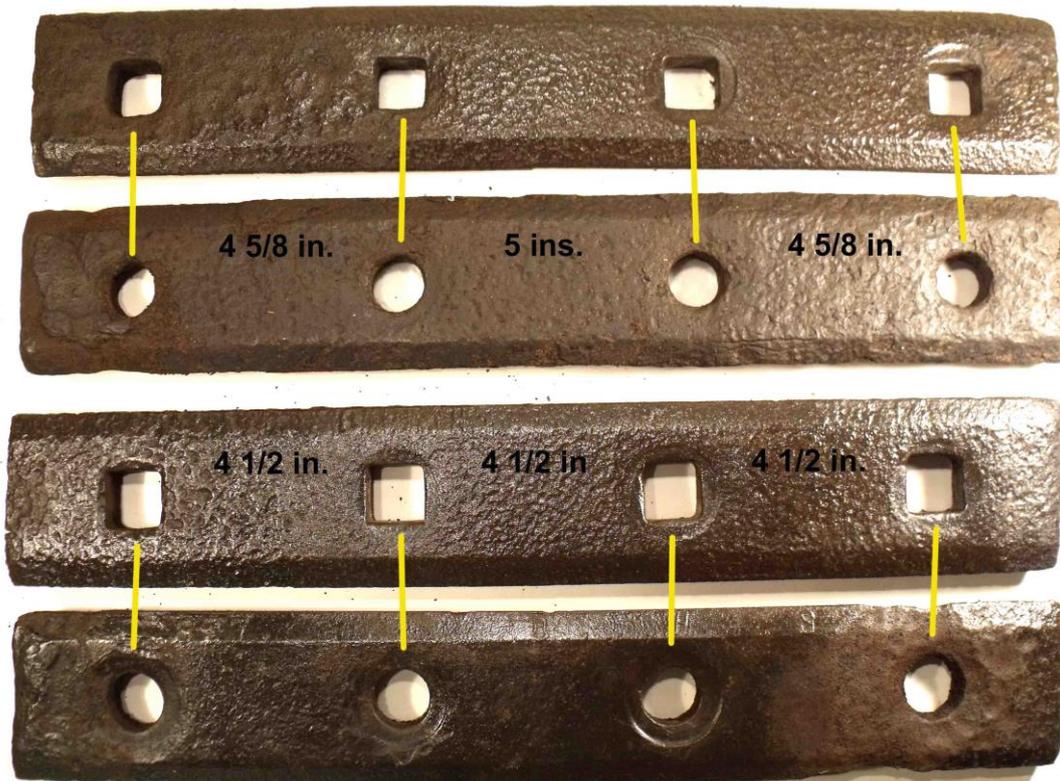
*Two pairs of matching plates collected on the Brading to Bembridge branch, that wouldn't have been able to fit the same rail or at least setting the expansion gap would have been difficult in pre-drilled rail. The lower plate has indentations made by the washers and even from the nut visible on the second hole from left.*

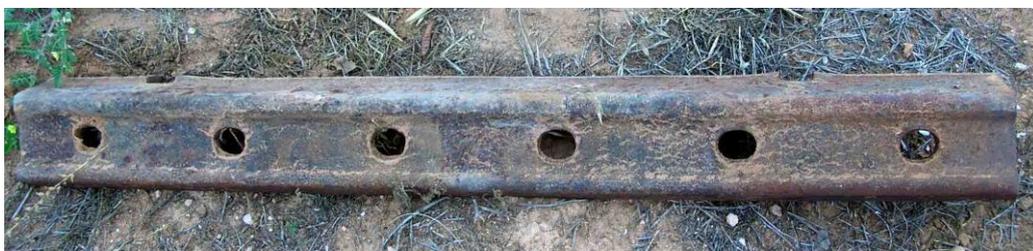
*Above: Fish plates with oval shaped holes can be found further afield - this one was found on a dismantled railway in South Australia; walking the track-bed looked similar to the FY&N with the same bolts and dog spikes scattered about. In 1919 re-laying the track in S.A. meant they adopted their own construction methods rather than British as previously. This is an 'L' shaped six hole plate made by B.H.P. Co. Ltd. Australia, which was also spiked to the sleepers to prevent rail-creep.*

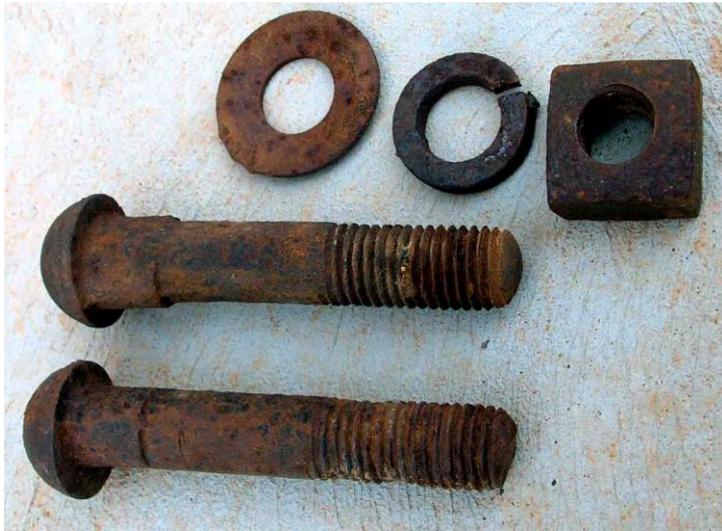
*Oval necked fish bolts found at Peringa on the Barmera line in South Australia opened in 1913 and closed in 1968 – the smaller track fixings were almost identical to the FY&N*

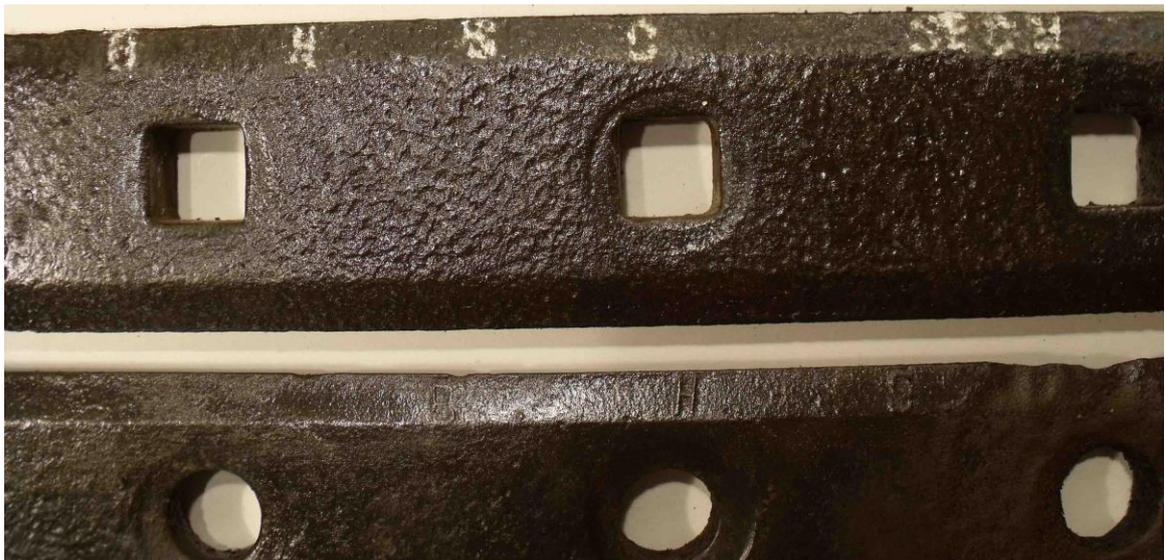
*Above: two plates from the Bembridge line that match physically but with slightly different brand marking, so not rolled at the same time, once they were cleaned up 'B. H. S.' was found on the lower plate – could this be Bembridge Harbour Scheme? The initials turn out to be more prosaic: the upper plate has B.H.S.C. but also SECR (albeit the 'R' is inverted) which is the South East & Chatham Rly formed in 1898 and BHSC almost certainly stands for 'Barrow Haematite Steel Co.' Why the IWR (by this date operating the line) were using SECR materials would be interesting to know.*

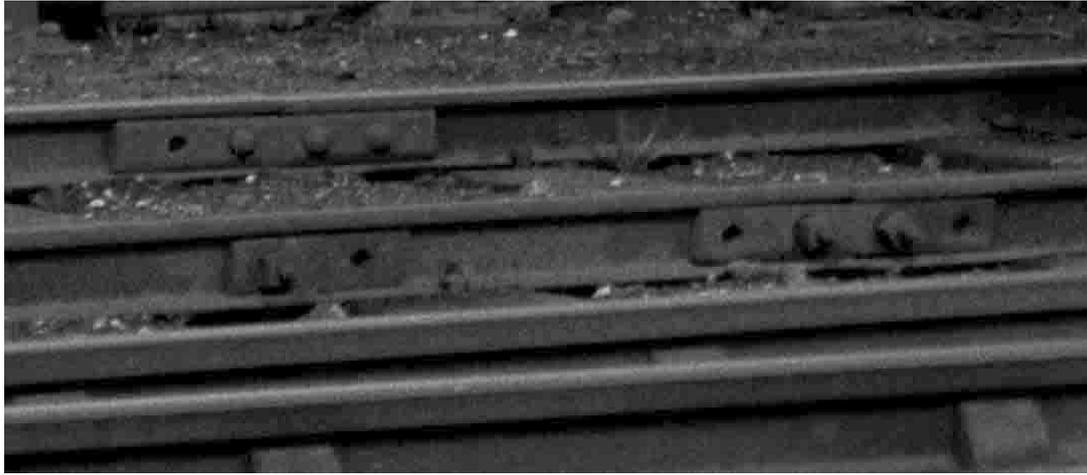
*Above: Continuing with the topic of mismatching rails and fish plates: above is a detail from a photo taken in c1930 at Newport Yard which shows how connecting two dissimilar flatbed rails with un-matched fish plates could be problematical – by this time the yard had almost been fully converted to chaired track so this might have been seen as only a temporary measure – (top left) a four-hole plate with only three bolts fitted and (centre right) the other has only two bolts fitted – good enough for the yard!*

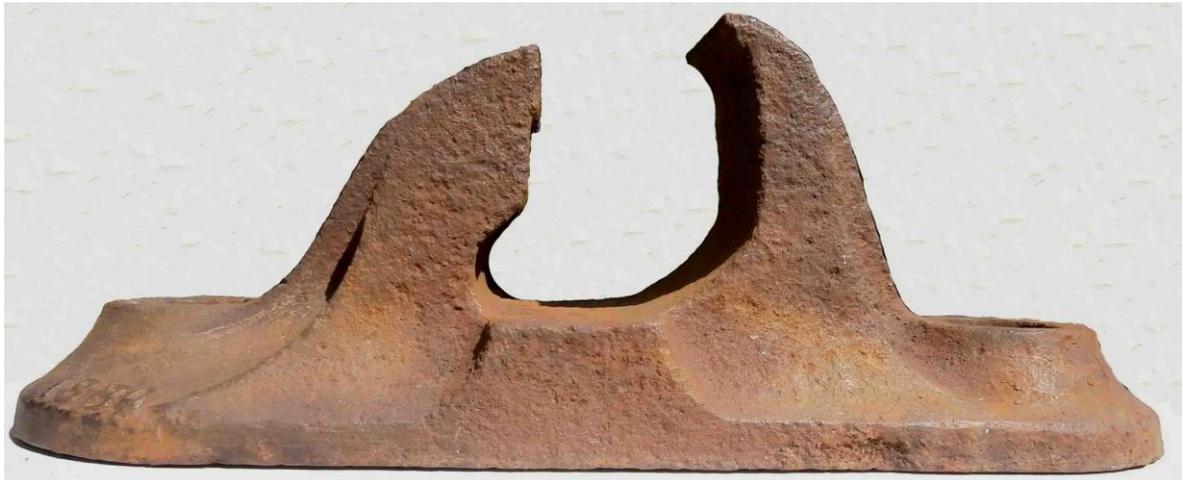
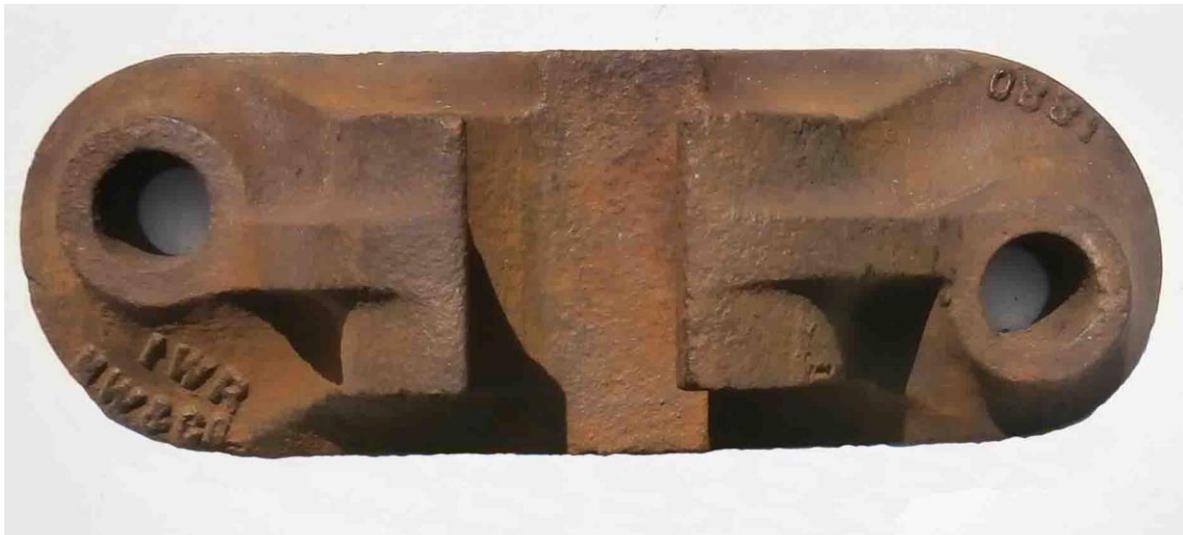
*Side and plan views of Isle of Wight Railway Co. rail chair cast in 1880 by Head & Wrightson, Teesdale, a major iron works that supplied railway materials worldwide.*

Chairs (*pictured above*) were first considered by the IWR in 1877 and they gradually converted their track to steel double headed rail.

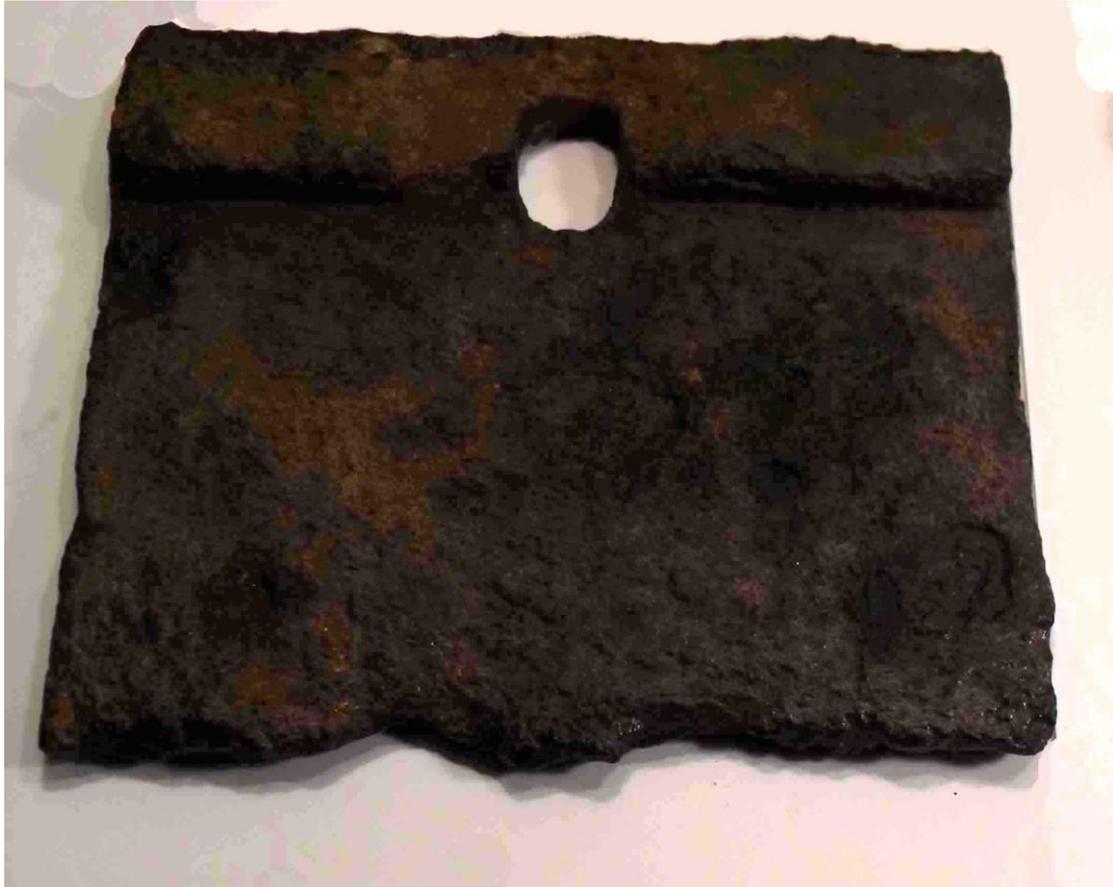
*Fragment of a large base or bed plate 7" wide x 7 ½" used on rectangular sleepers.*

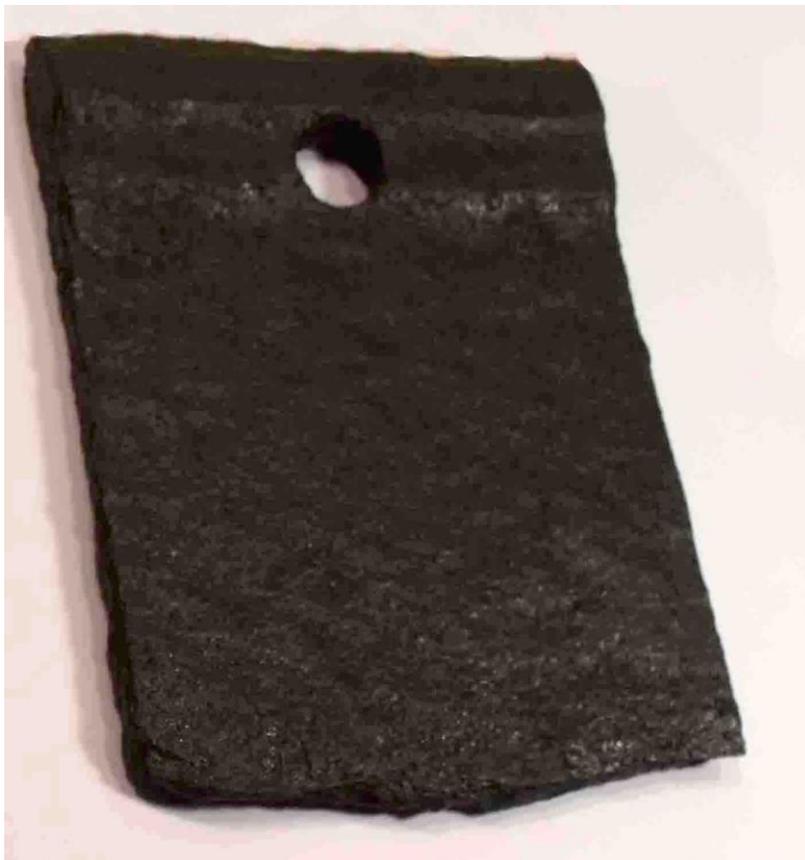
*Small base plate 4 ½" x 8" as used on half round sleepers (see below) special bolts secured the assembly. The rails had a 4 ½" wide base which fit these plates - the rail and plates have to match so as to anchor the rail effectively.*

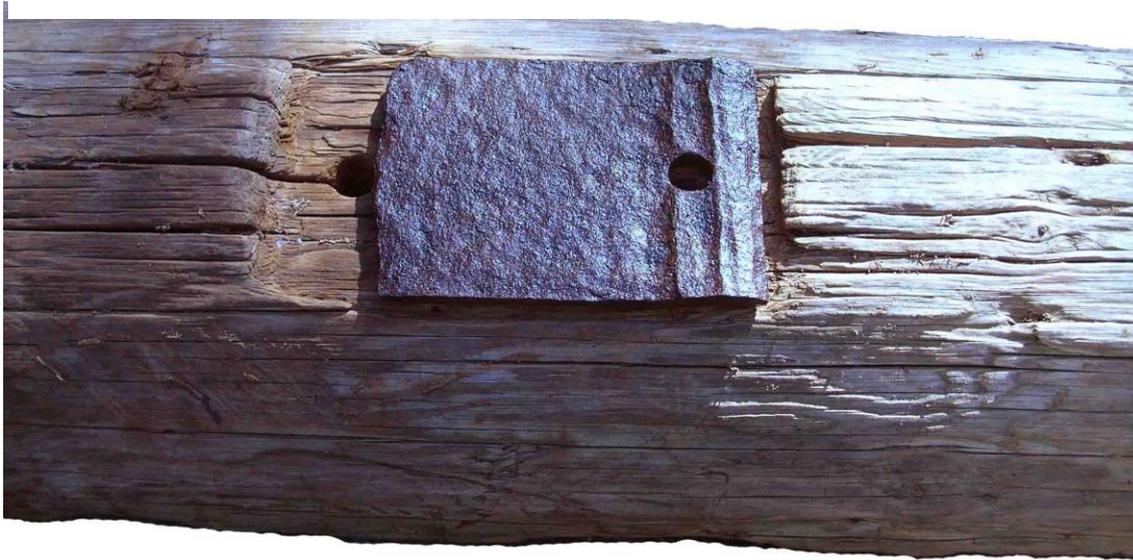
*Below: An original (broken) bed plate positioned on top of a portion of original FY&N half round sleeper that survived as a fence post. Each half round sleeper had to be cut and shaped to receive the plate and the through bolt holes line up pretty well.*

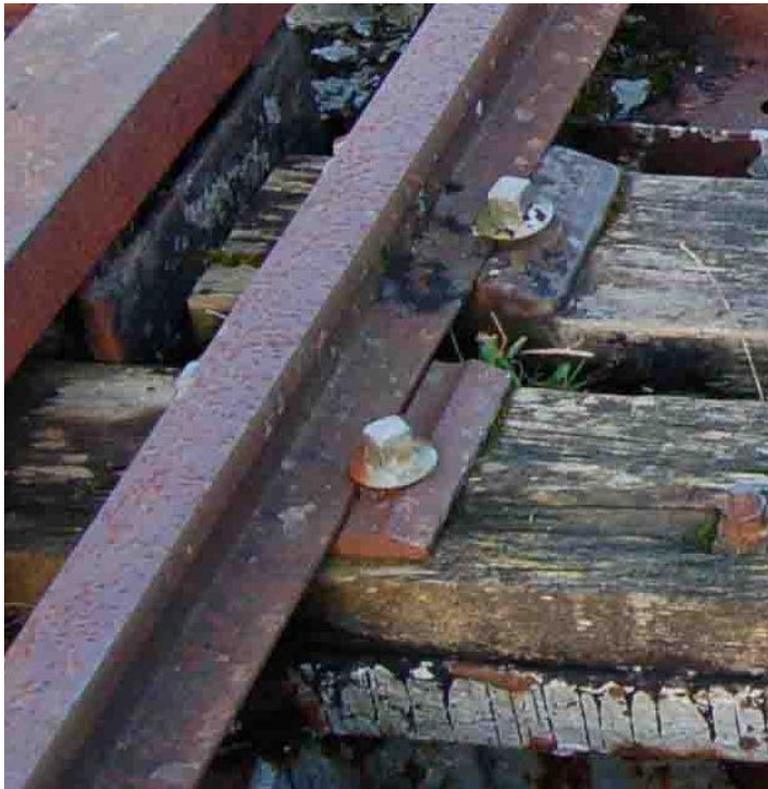
*Left: a detail from a photo of abandoned track in Ireland which has used similar plates to that on the FY&N, the nearest has the same profile as the original (above) while the plate behind has a 'stepped' profile similar to the larger FY&N type.*

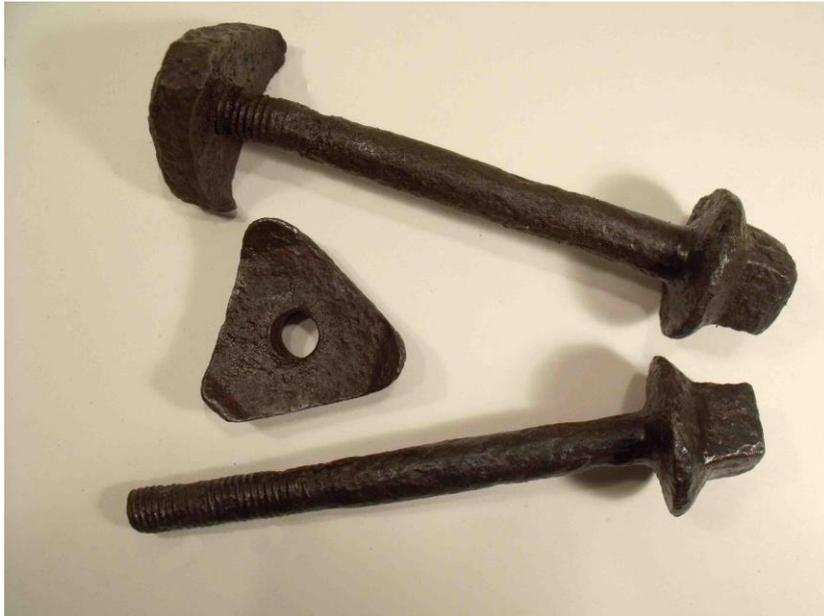
*Mushroom headed bolts  $\frac{5}{8}$ " dia. by  $7\frac{1}{2}$ " long including the head. They were found on the line with fang nuts fitted that can still be engaged.*

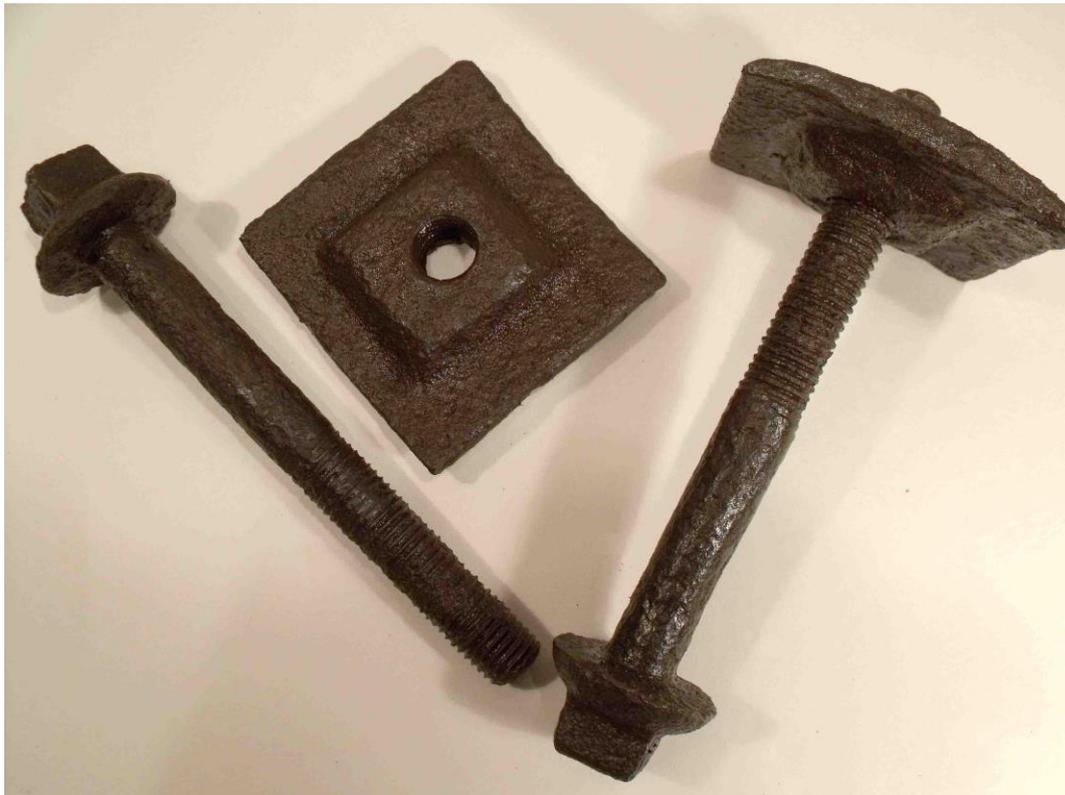
*Above: These bolts are  $\frac{3}{4}$ " x  $7\frac{1}{2}$ " and were found with these square nuts still fitted, a blow lamp soon loosened them. However, it's not clear which way the nuts were to be fitted when in use.*

It's quite likely that the heavier bolts were used on the larger bed plates placed on the rectangular sleepers. These screw fixings (or broken parts) have been found along the whole length of the FY&N.

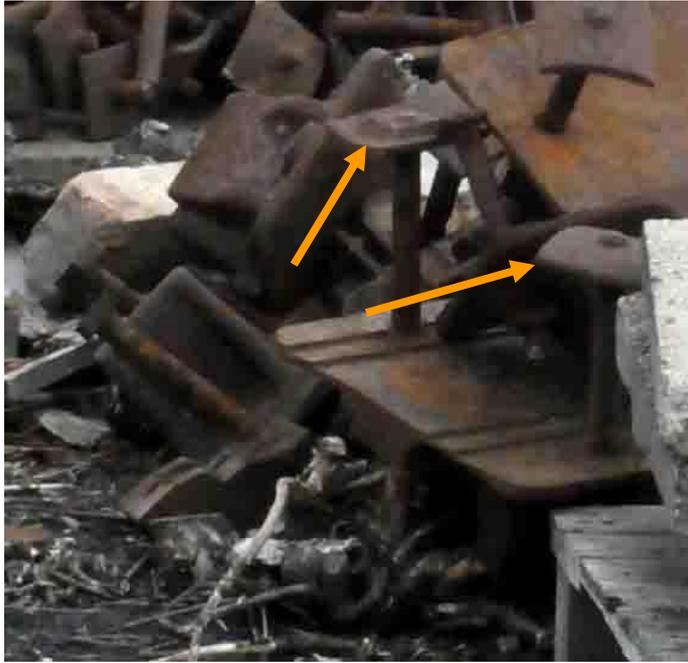
*Left: Photo taken at Didcot Railway Centre of some old railway chairs taken out of decayed sleepers which still have their fixings attached. The square nuts (arrowed) have been fitted on both ways round, so it's still unknown which is the 'right' way up, but probably as the right hand example and the others visible.*

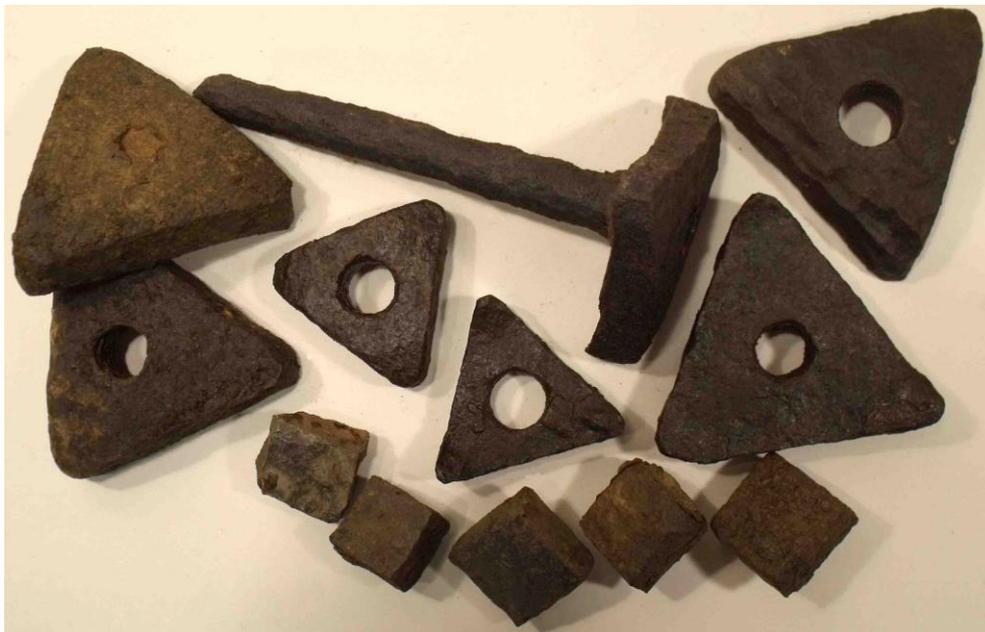
*Above: a selection of fang-bolt nuts found on the Brading to Bembridge line and their square heads smashed off during demolition. The smaller fang nuts have only been found on the Bembridge line - they are an oddity as their threads fit the large 3/4 " diameter bolts, the larger nuts suit smaller diameter 5/8" bolts.*

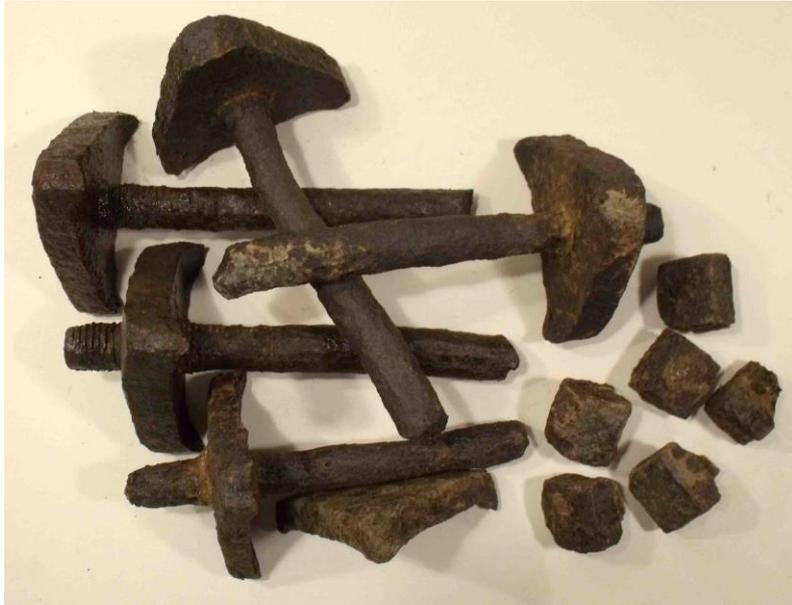
*Left: A selection of through-bolts and 'fang nuts' from the Central Railway, some maybe from the original lines. It was usual for platelayers to smash the bolt heads off for rapid dismantling of track during any replacement programme.*

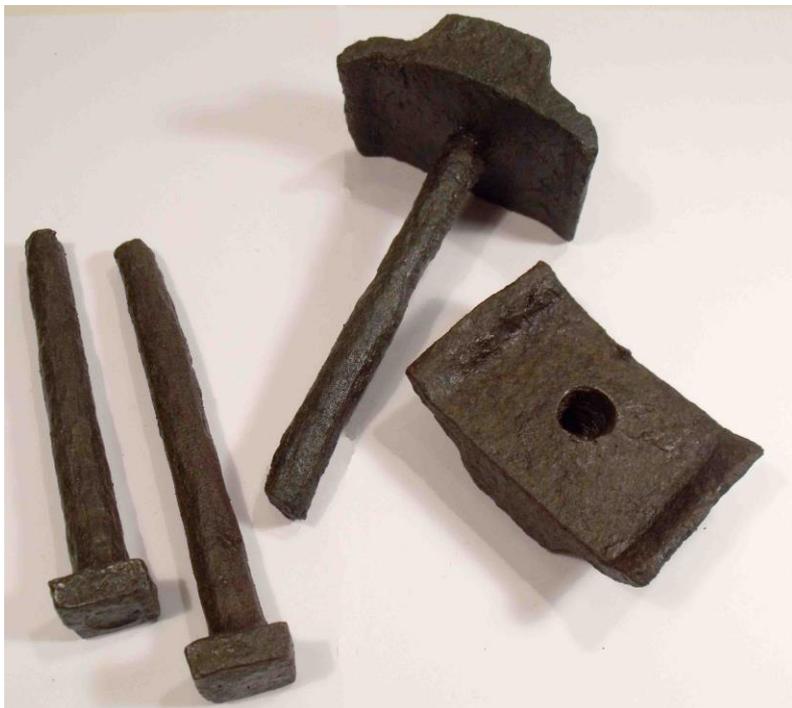
*Through-bolts from Asheby siding and so far, this design of grip nut hasn't appeared anywhere else on the island or in any literature. The track was laid in the 1870's*

Another style of 'fang bolt' type fixing seems to have been used by the R.N.R., at least they've been found on the Asheby branch that connected the chalk pit at Asheby Down, almost three quarters of a mile from the siding. Numerous examples have been found and although crude, look quite effective (below). It's tempting to think that

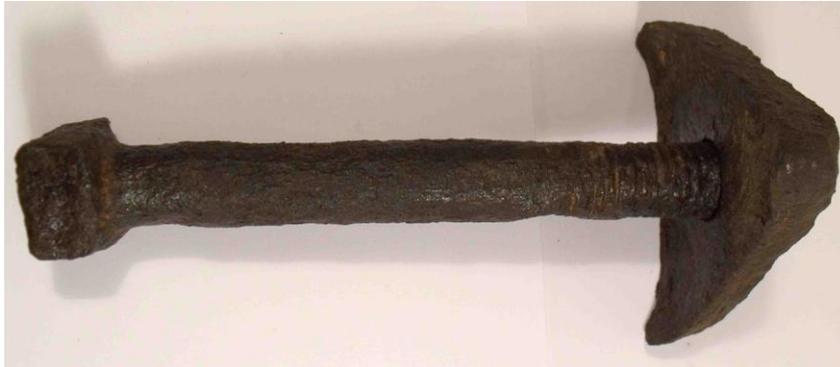
Left: A lone through bolt found on the Shanklin to Ventnor section of the IWR where there is also little to find, the deep square head is different to the other examples.

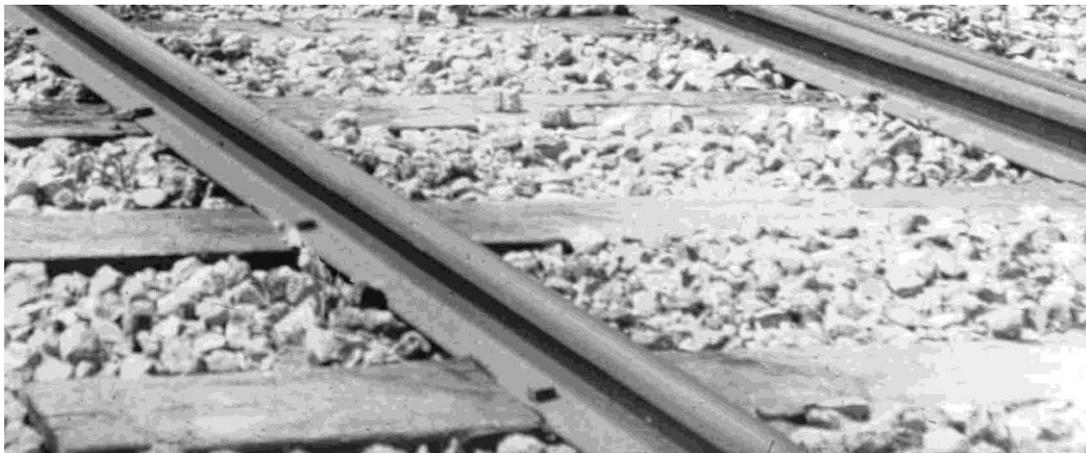
*Above: a track detail from a photo of the NGStL line outside the tunnel which shows the square headed bolts through both sides of the rail flange at each sleeper.*

Bolting the rails to the sleepers is obviously more secure and it was the practice to do this on curves, in stations and tunnels where derailment from out-of-gauge track would be more problematic. It seems that the IWCR up-graded their track this way as time passed and when the NGStL railway was being planned negotiations were held with the IWCR who were intended to operate the line for a percentage of takings. One of the conditions made by IWCR was that the NGStL 'road should be fanged throughout', this probably after the un-happy experience of the FY&N line on which IWCR operated the service (more below).

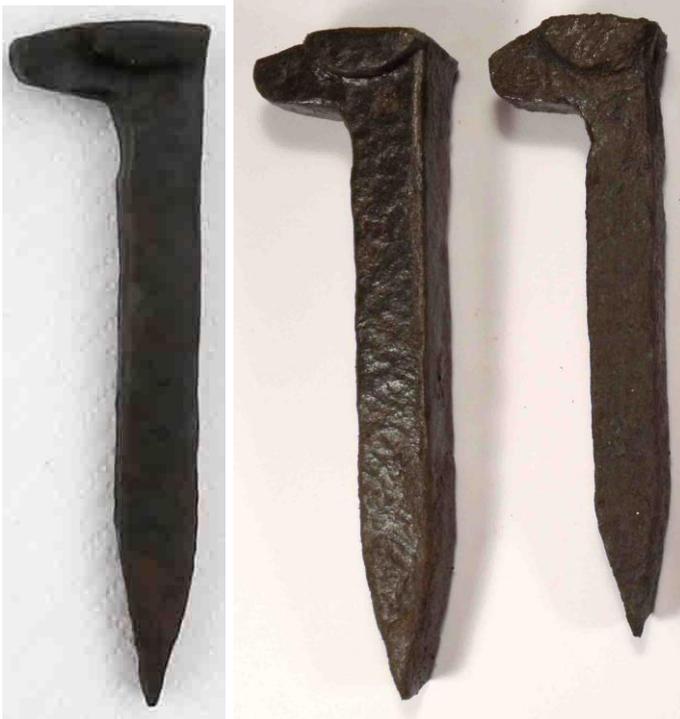
*Typical dog spikes, the name comes from the shape of the head, the 'nose' overhangs the rail flange and the 'ears' are to provide points to lever out the spikes with an adapted crow bar.*

*Left and centre: 5 ½" long 5/8" thick spikes found on IWCR lines Ryde and Sandown respectively.*

*Right: smaller at 5" long 1/2" thick FY&N spikes of a type found along the whole line without exception – no other size of spike has been found on the FY&N.*

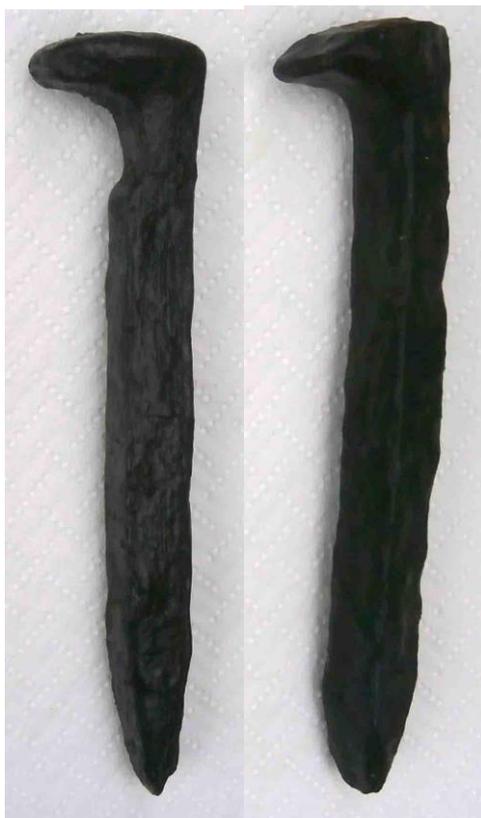
*These two spikes are similar in style, but cruder in design not having the means to lever them from the sleepers.*

*Left: 6" long 7/16" thick and looks older than the 'dog spike' type. It was found on the Cowes line and could possibly be a spike from the original CNR company. It is fairly worn under the head indicating prolonged service compared to the other.*

*Right: 6" long 1/2" thick, one of several similar spikes found on the Ashy chalk pit branch constructed in the late 1870's*

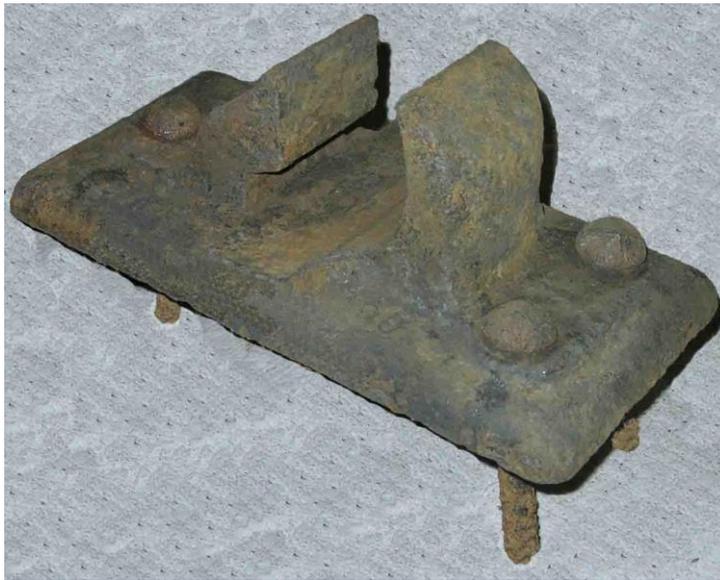
*Below left: most likely laid by SR after grouping when relaying the islands lines often included the use of second-hand components, but this 1902 LSWR chair still has its spikes attached illustrating the dome headed spike in use and the remains of wooden 'treenails' which are inserted 'rawl-plug' fashion into pre-drilled holes in the sleeper with the iron spike driven in. It was found on the Sandown line in the river.*

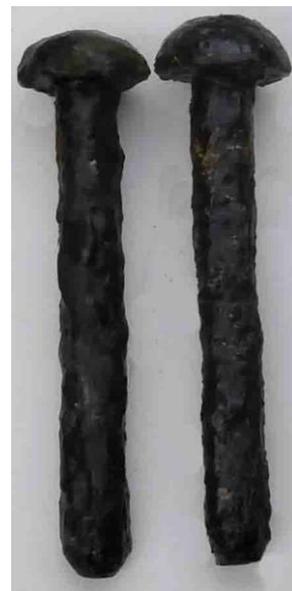
*Above right: Dome or pot head spikes from the Sandown line*
