## A Survey of Railway Track on Pre-Grouping Island Railway Companies

by Richard Brimson

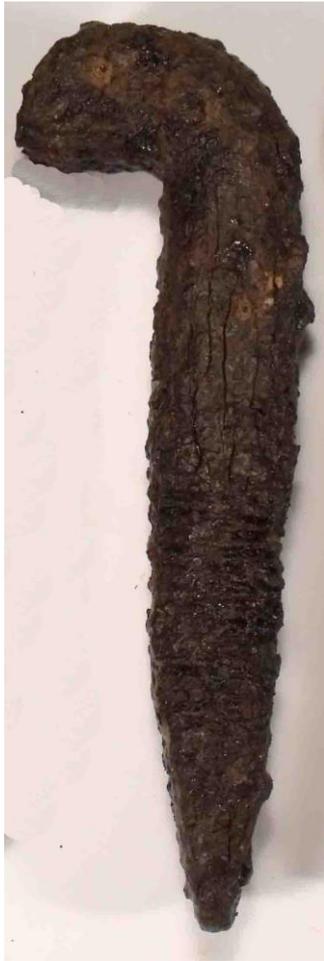
*This is a badly corroded spike (5 ½" long x ¾") made from circular section bar folded over to form the head and a thread of some sort applied half way up the body (just visible), it's not certain whether the threaded chisel point is to screw the thing into a pre-drilled hole in the wood (which would require a special tool) or to be hammered in and the ridges providing grip, probably the latter. It was found at Ashey.*

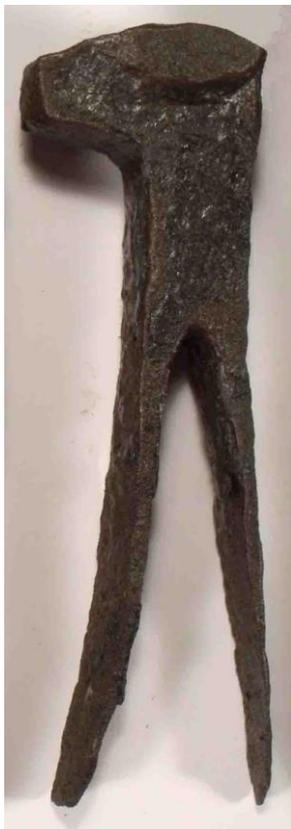
*This curious object 5" long ¾" thick, again, found at Ashey, was thought to be a damaged spike or an apprentice's joke project. There seems no obvious advantage to having two rather fragile looking spikes to hammer in when one usually serves well enough. However, researching American publications on track construction Marshall M. Kirkman's 'Science of Railways' series from 1904 has a passage in which he describes dog spikes and then mentions fang bolts being favoured in England (presumably not in the US) and then goes on:*

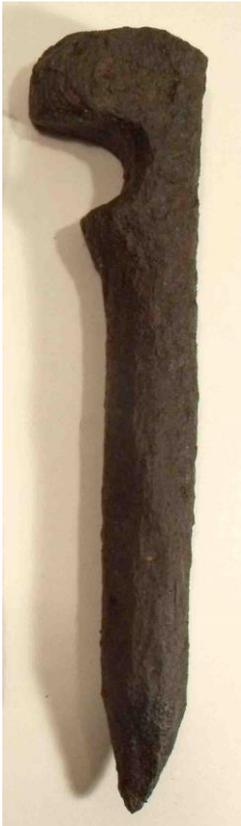
*This 6 ¼" long spike was found on the track-side of the Brading to Bembridge line and appears to be a rather singular object. It almost certainly has to be used to hold a flat bottom rail much like a dog spike does, (unless it has some other special purpose, perhaps a keep for a gate latch!), but surely the only way it can be correctly fitted is to drill the sleeper at a pre-set position, hammer the spike home and slide the rail flange into the spike's 'jaws'. It might be for precision alignment, but having seen the wedge spike, surely anything is possible!*

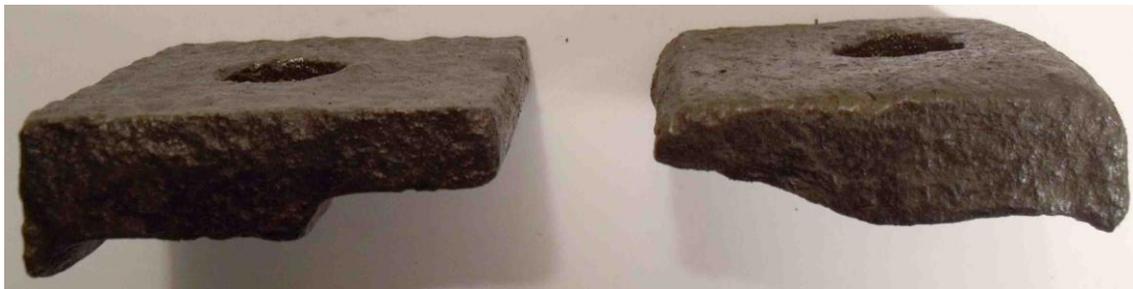
*Above: rail clips 3 x 3"  
Left: from the Sandown line  
Right: Bembridge line.*

Where it is inconvenient to drill a hole in the rail flange to install a through bolt, a clip can be fitted using a screw alongside the rail flange.

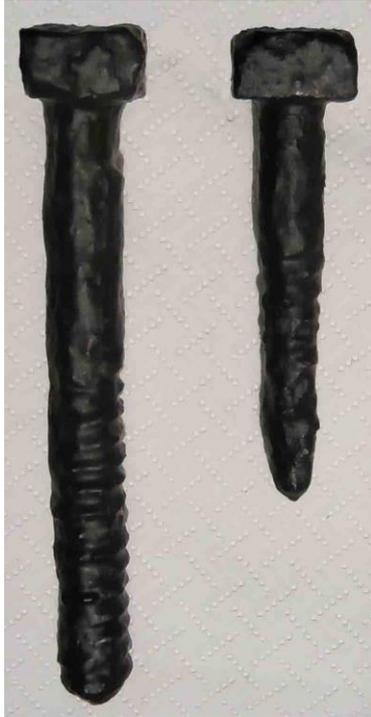
*Left: Coach Screws have multiple uses, but when found on the track it would probably have been used for securing rail clips above or the rail itself.*

*Far left: This screw has been worn on the shank just beneath the head which suggests that it was used to secure a rail through the hole in the flange, instead of a fang bolt. Both were found on the Sandown line.*

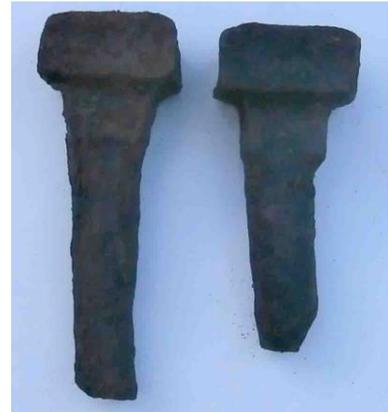
*Above: These fish plate bolts were used on the Brading to Bembridge line, they have square shanks, but also square heads – the reason for this is unclear – the bolt is already secure with the square neck why the need for a square head which can't be turned?*

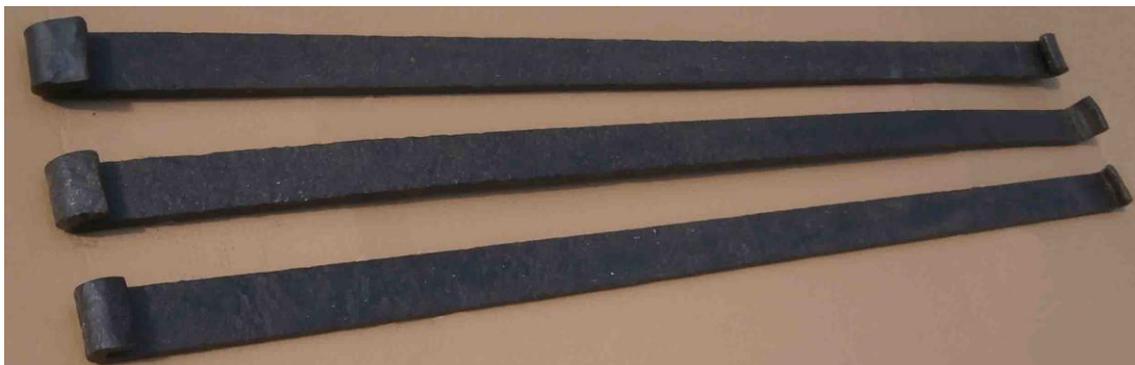
*Above are three gauge ties, the R.H. ends damaged on dismantling –  
The upper example is from the FY&N,  
Centre: was used on the Ryde Newport line  
Lower: was found on the Newport to Sandown line.*

Measurements of the ties strongly suggest that the two IWCR ties were used with the same sized rail which happens to be the same as the piece of EV 1881 rail found on the Sandown line. The FY&N tie is slightly shorter and suits the piece of Blaenavon rail found on that line (see above).

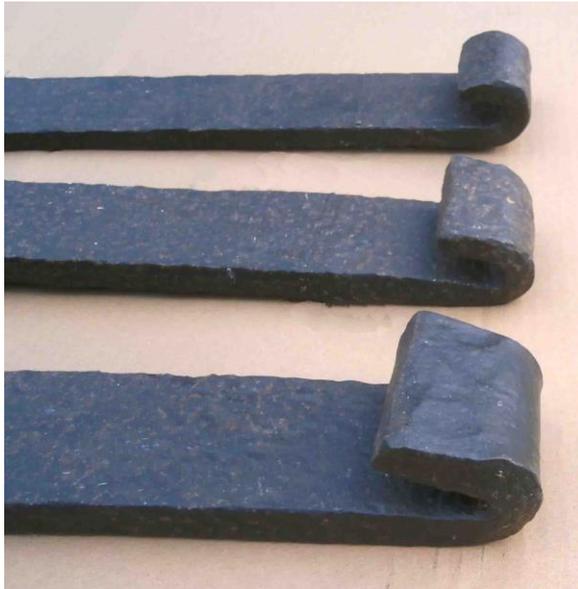
*Left: detail of the folded bar ends that grip the rail flange. Nearest is the FY&N tie, centre RNR, rear the Sandown.*

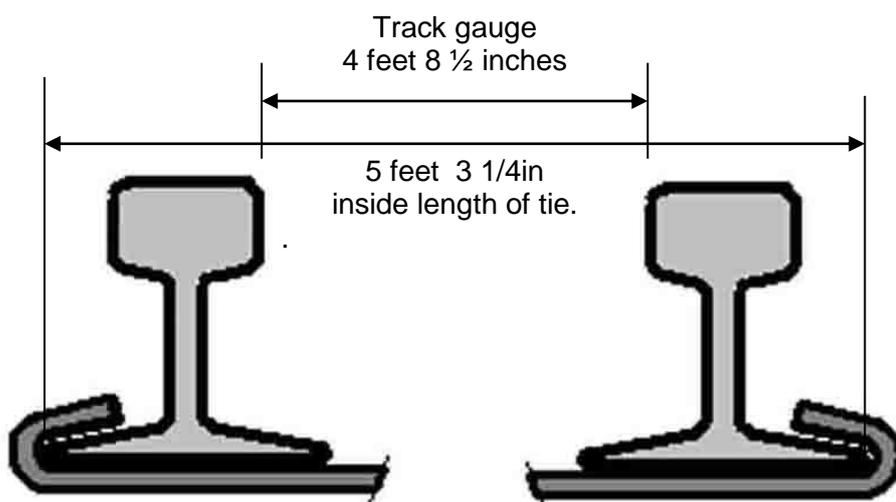
However, the two IWCR ties from the Ryde and Sandown lines have an inside length of exactly sixty four inches which suits a rail like the 1881 piece with a five inch base and a two and a half inch wide head.

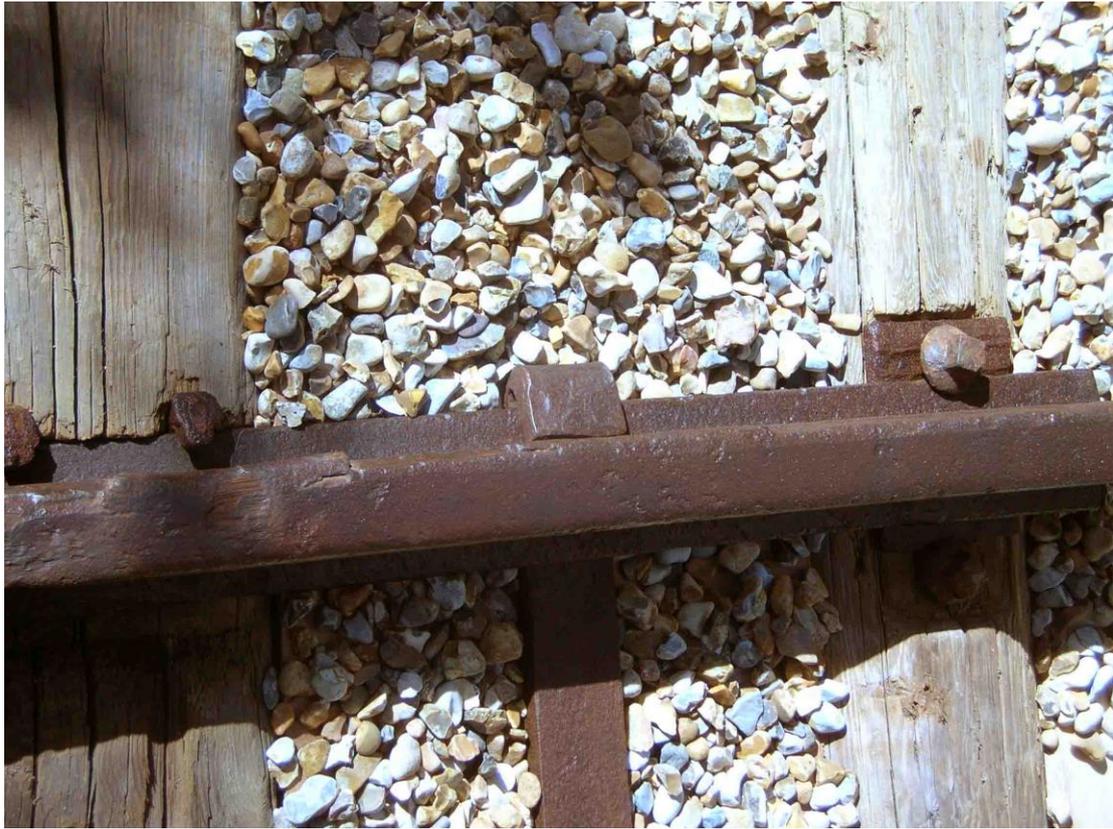
Above: A set-up of a portion of FY&N track as it would have looked using actual parts from the line except for the rail. On the left is a 10 x 5 in. rectangular sleeper with two dog spikes inserted into the original sockets. Right: a 10 x 5 in. half round sleeper and bed plate fitted with a mushroom fang bolt and centre is a gauge tie.

In less than nine months from the opening of the FY&N line, the IWCR who operated the traffic, complained about the condition of the line and even threatened to undertake the necessary repairs themselves at one point. The condition of the track was a problem for the FY&N and any receipts from traffic was being spent on the upkeep of the line until the receiver was appointed in August 1893. What was the reason for the poor state of track? It could be the method of construction, at the end of 1887 Herbert Simmons, the then manager of the IWCR informed the board 'as to the manner in which the rails are being laid upon the Freshwater line' The board decided that 'this company cannot interfere in the matter'. This was eighteen months before the line opened; it seems that Simmons could see problems ahead for his company given that they had agreed to use the line. The problem could well be the bed plates; both the examples found on the line were broken, easily done as they are made of thin cast iron and if they weren't seated on a flat surface could easily break. An unknown proportion of the line had half round sleepers which had to be sawn and adzed or chiselled to form a seat for the bed plate; the stress of the bolts to secure the rail would be considerable and any unevenness could break the plate. From

reports it was difficult for the track to be kept to gauge and at the 1895 enquiry many of the nine by four and half inch sleepers were rotten and being replaced by ten by five inch sleepers, the report doesn't mention the shape of the sleepers.

A reason for the need for tightness of these bolts is that this would be the only restraint to prevent rail-creep in this system, a problem where several factors contribute; traffic movement and thermal expansion among them, gradually moves the rails and closes up the expansion gaps and if several lengths of rail collect together broken fish bolts result in a large gap created and the wheels can 'batter' the end of the rail which could result in fracture, these rails weren't able to be secured through the flange as was then usual. With spiked track there are usually holes at each end of the rail to bolt through which help prevent rail-creep or as in one example of a rail found 'notches' have been cut in the flange to receive dog spikes to prevent rail creep.

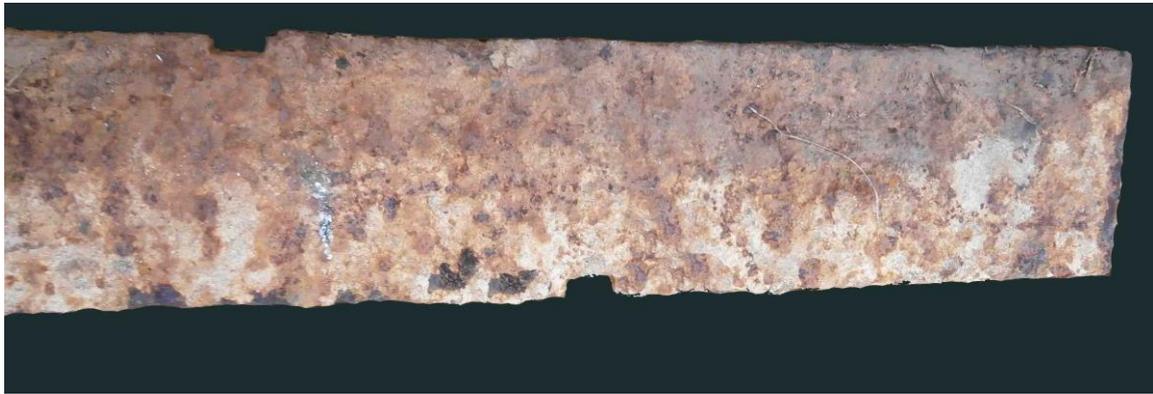
*Preventing rail creep: two pieces of 4 inch wide flat bottom iron rail found in sidings.*

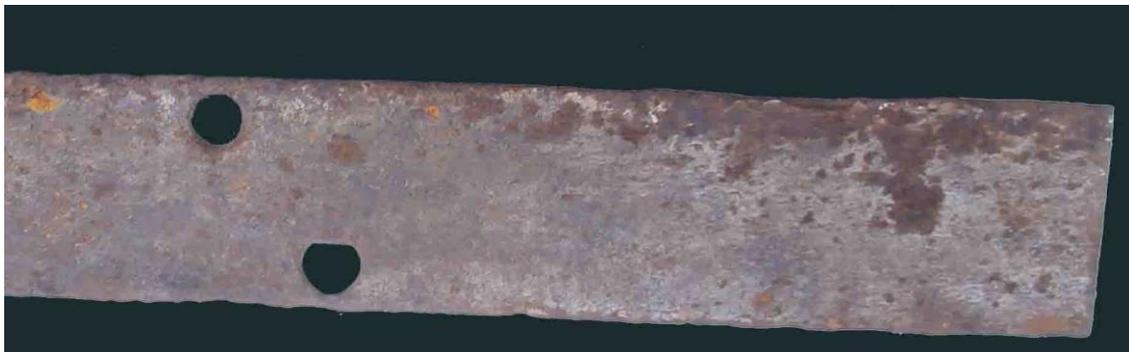
*Above: with notched edges for dog spikes at 9 ½ & 14 ½ inches from rail end.*

*Below: holes drilled or punched for bolts 13 ½ & 15 ½ inches from rail end, dog spikes would secure the rest of their rail lengths.*

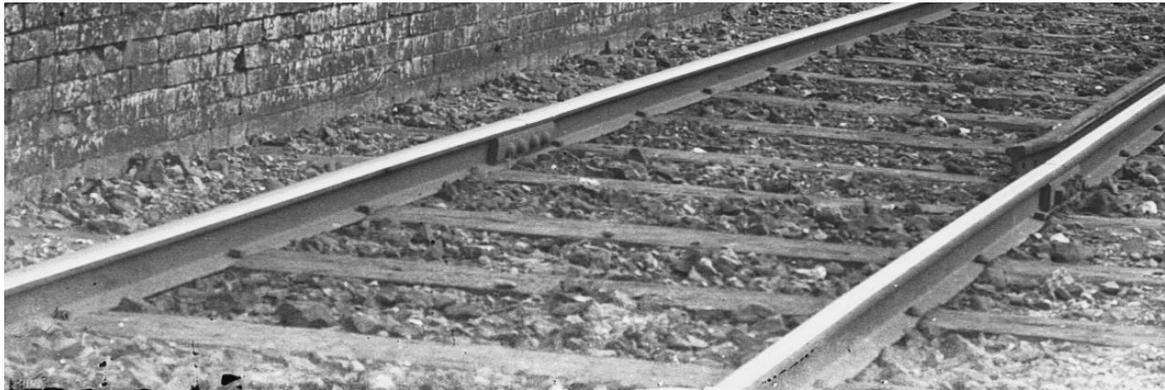
*Above: IWCR track – a detail from a photo of Shide station which shows the nature of their track. Inside the rails (visible on left rail) are square headed fang bolts at each sleeper.*

*Left: further detail R.H. rail shows the outside flange with one bolt (red arrow) at the fish plate the others are dome headed spikes (arrowed orange).*

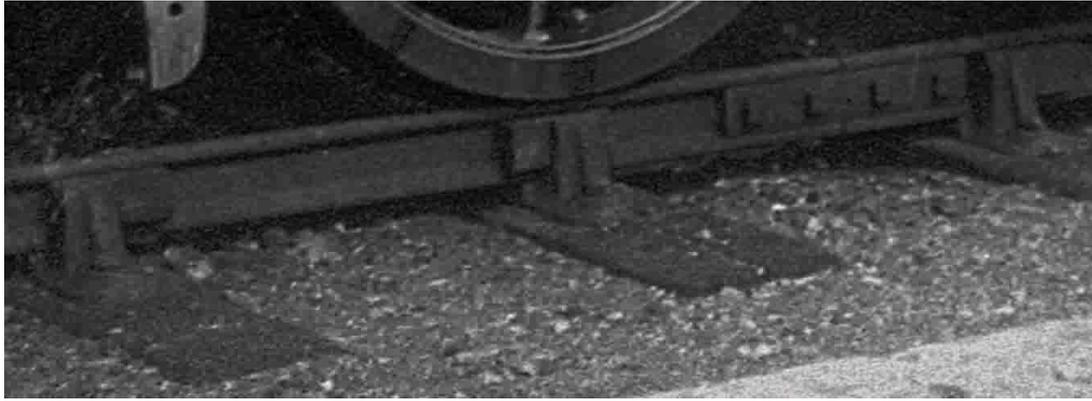
*Above: Detail of IWR double headed rail in chairs from a photo taken at Shanklin station early 1920s.*

British track for the most part adopted rail chairs for main lines and only small companies and industrial lines in mines and quarries used flat bottom track. The IWR was able to afford to convert to chaired track on it's Ryde to Ventnor line although photos appear to show flat bottomed rail at Ventnor sometime after conversion, this might be because IWR bought steel rails which lasted longer being more durable. It's ironic that post WW2 British Railways moved away from chairs and adopted flat bottomed rail on base plates not so dissimilar to the FY&N.

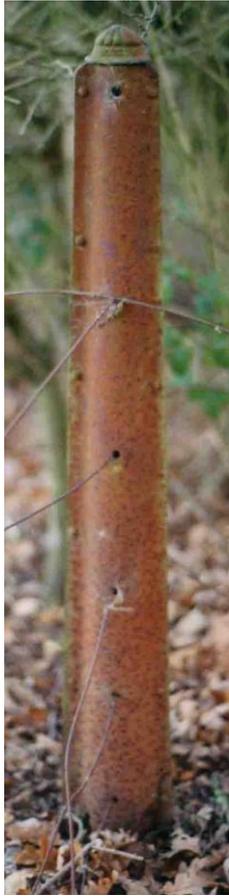
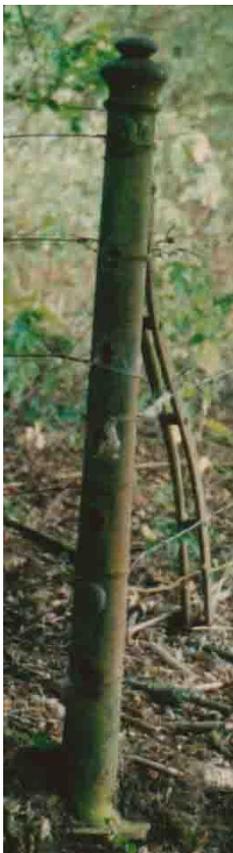
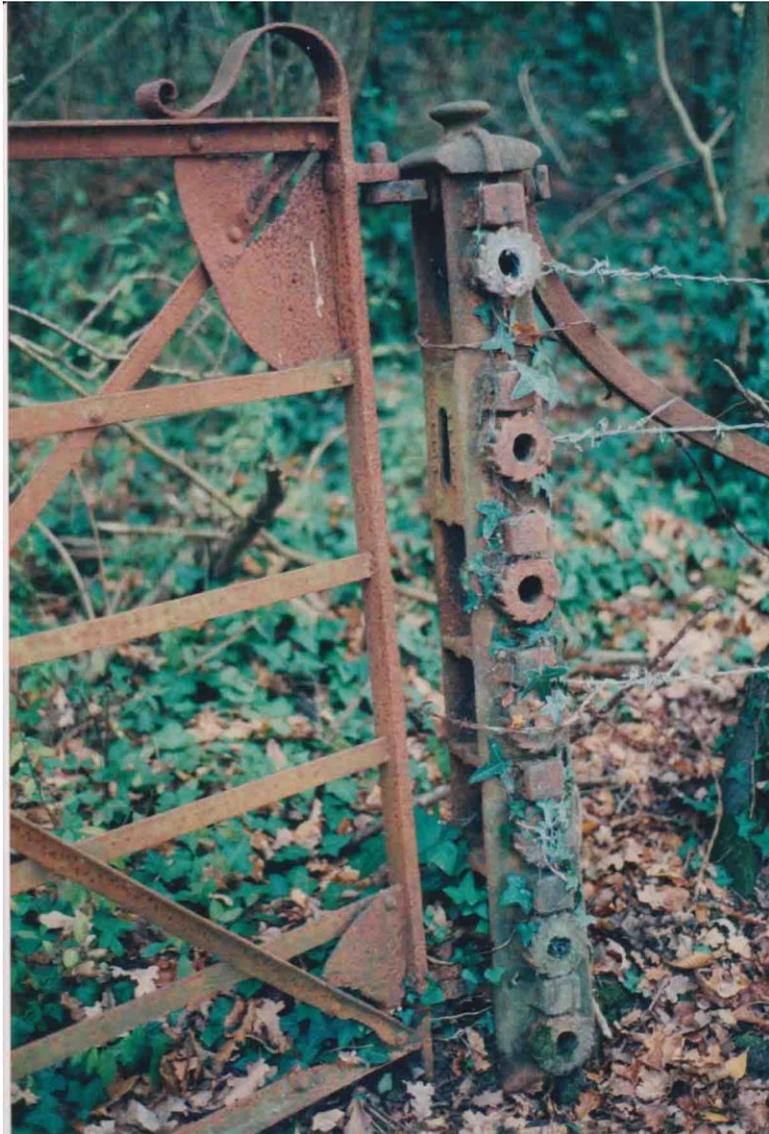
*One of the earlier wire fence manufacturers, Francis Morton fencing on the RNR:*

*Top left: a patent sheet iron standard still with its cast iron cap, once the top wire failed these were easily lost.*

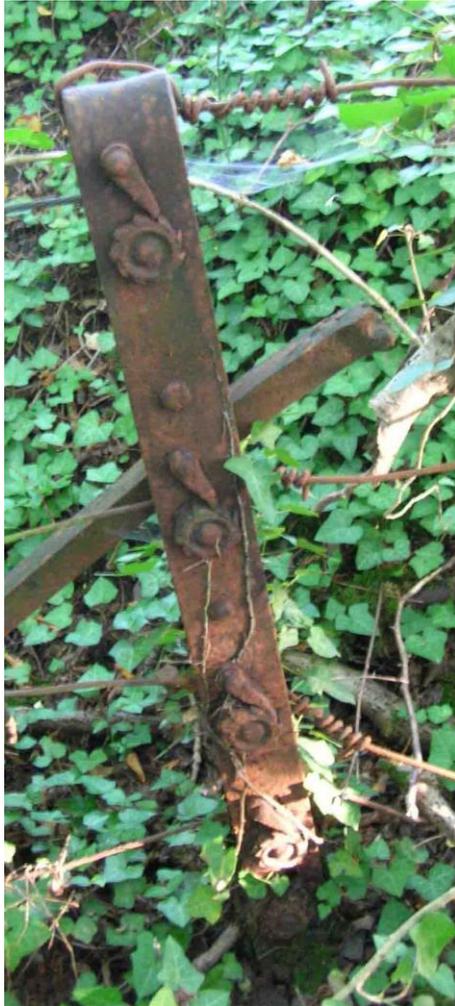
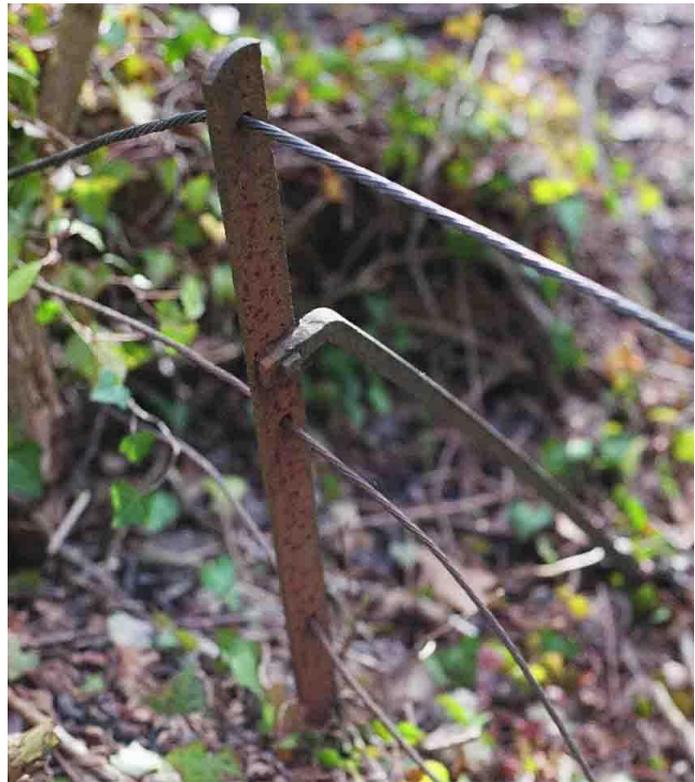
*Examples of Baylis, Jones & Baylis fencing on the RNR not so robust as the Francis Morton and much of it was replaced on long stretches of track.*

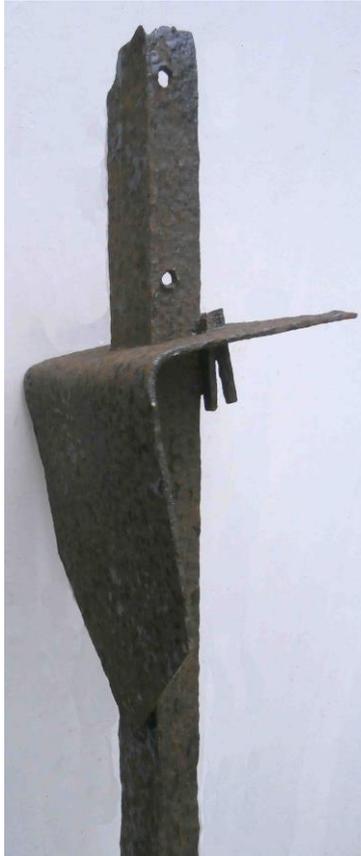
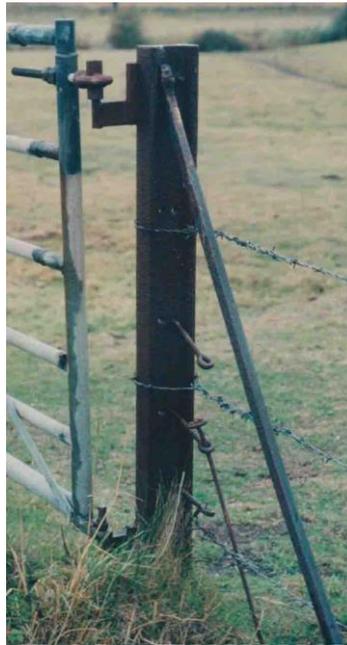
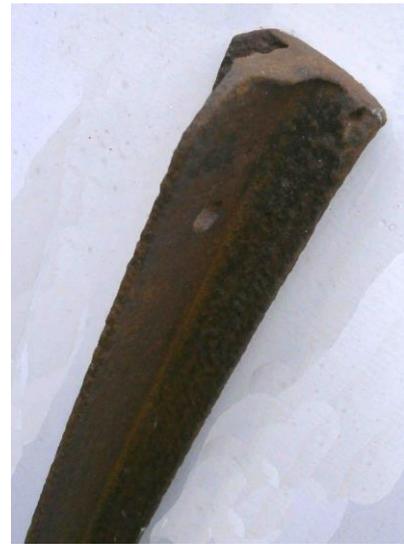
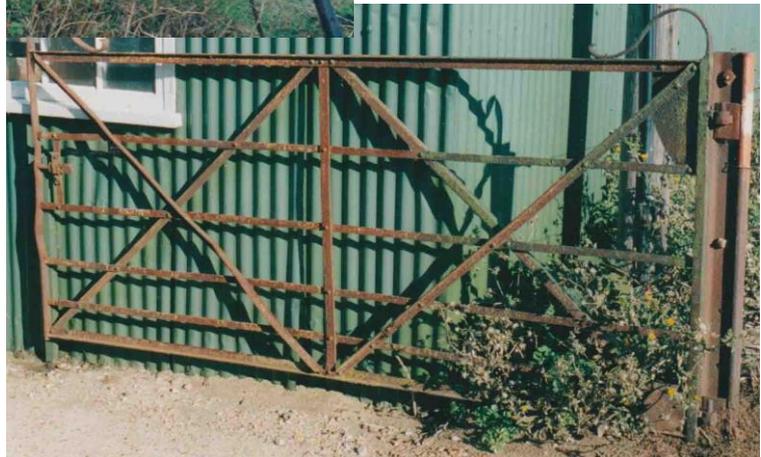
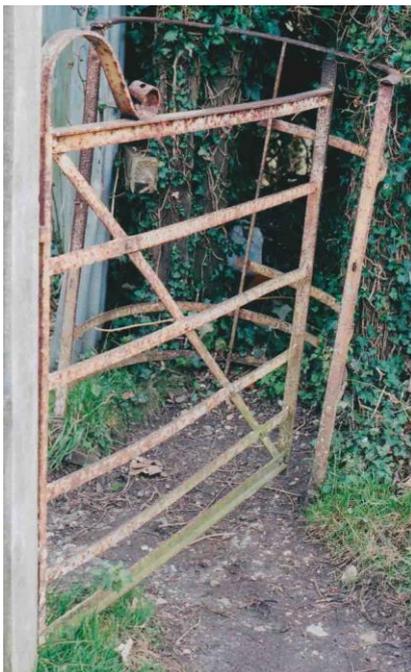
*Supplier unknown fencing and gates on the Bembridge line.*

*Above left: found on a spoil heap with a ground plate still fitted with two iron securing wedges to the remains of a standard.*

*Above right: the only original standard found on the line, as with all the extruded steel posts it had corroded at the base, the 'tee' section standards were 6 feet long.*

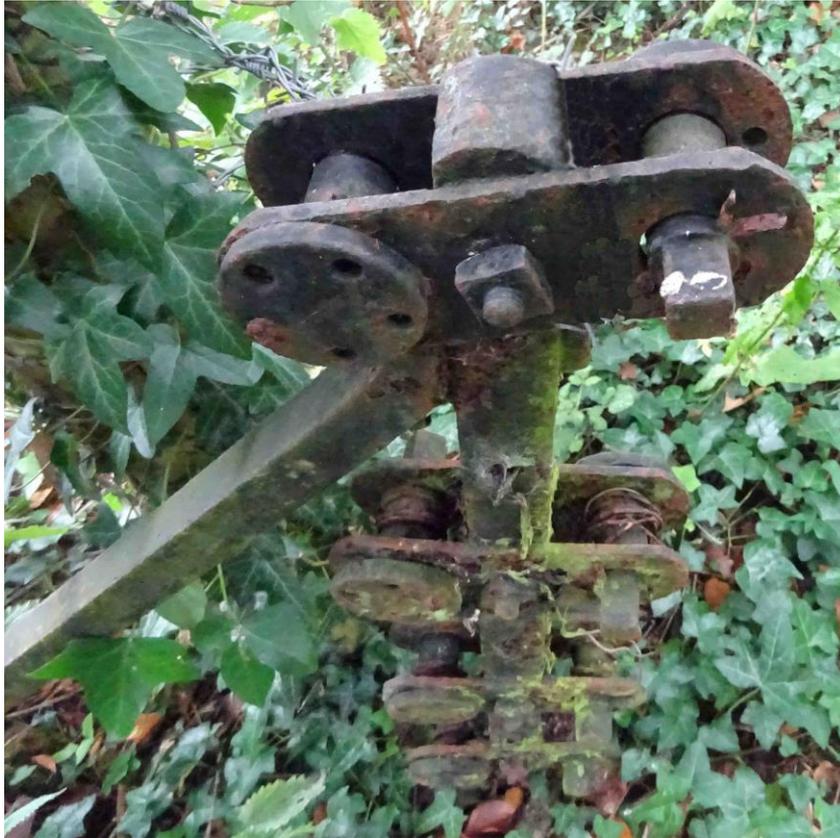
*Left: A typical straining post found along the line, made of wrought iron and hasn't decayed like steel fencing will.*

*The maker hasn't yet been identified. Odd examples were found on the Ryde and also Bembridge tracks.*

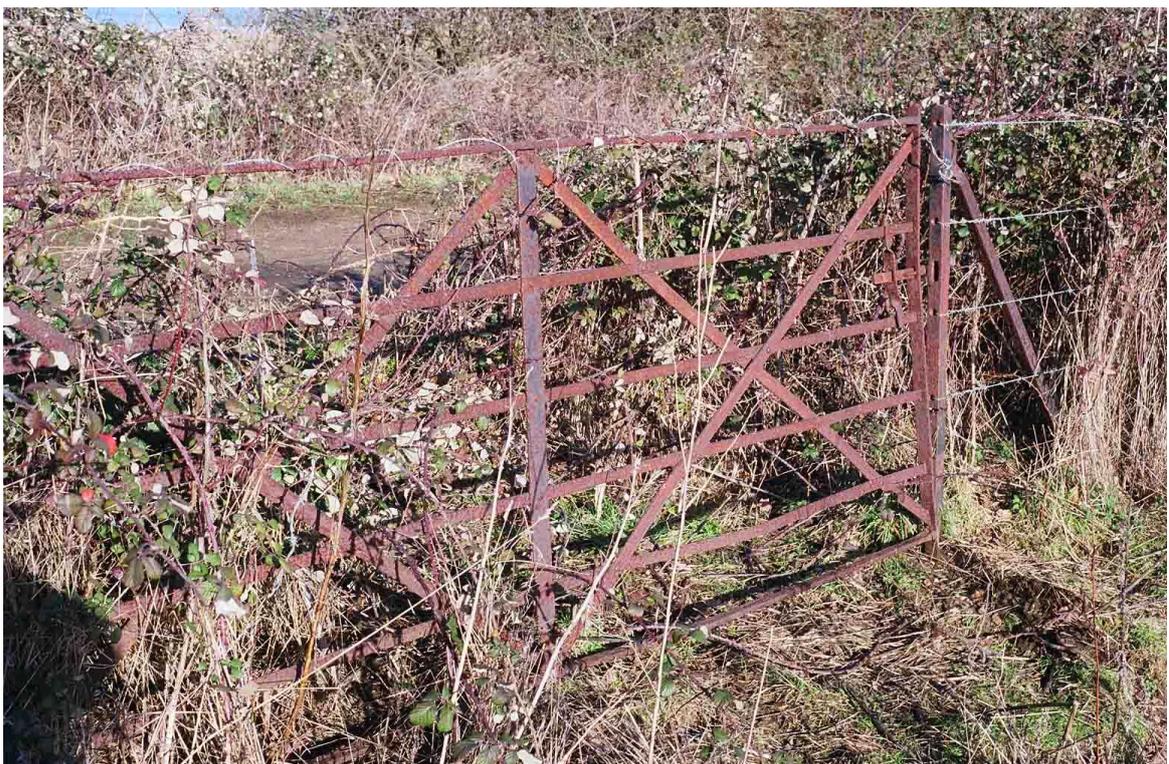
*Below: An occupation crossing gate with bracing post, there were many of these along the line illustrating how many farms and properties were divided by the railway which had to provide crossing points either gates or cattle creeps (small tunnels). The bracing posts proved inadequate though and SR reinforced them with double headed rail, this one near Yarmouth is the only un-modified example found.*

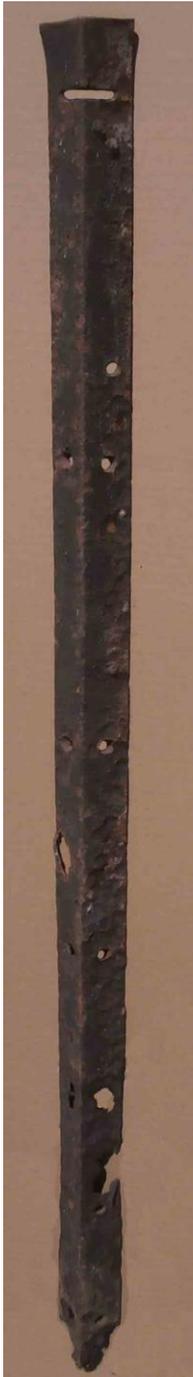
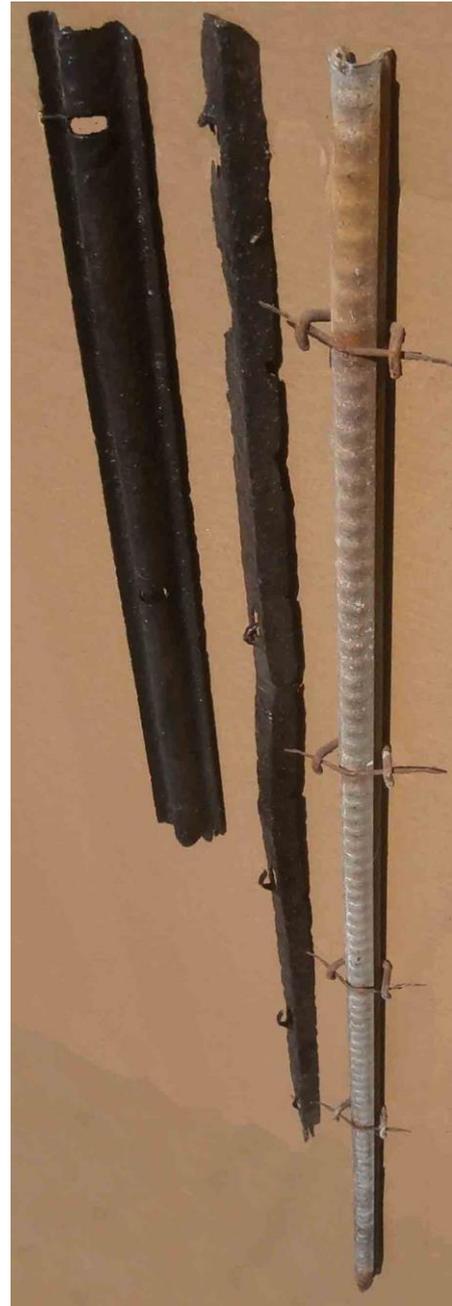
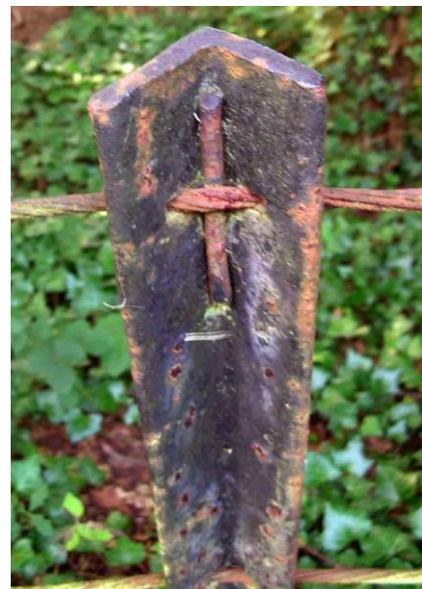
**FY&NR Cont.**

*Left: A standard which has decayed at ground level as they all did. The posts used were steel angle extrusions which were painted with a black varnish, a typical treatment before galvanising was widely used. This wasn't enough though and even replacements rusted quickly as well. The top has a slot if barbed wire is required, either type would be held by a wedge at the back. A whole post was 6' 6" long.*

*Right: Three droppers found on the line.*

*Centre: remains of an original 'L' cross section dropper the only one found, this still has some punched tags hammered over to grip the wires.*

*Right: The company lost so much iron fencing they replaced it with split wooden sleepers and these galvanised droppers and many are still to be found in situ on the line.*

*Left: Some of these droppers were found rusted away, this is a surviving top half, BJB were known suppliers of this corrugated sheet metal design.*

*Lower right: Angle iron standard on the RNR probably a replacement, but here showing the fixing of the top strand wire with a small wedge just as the FY&N ones would have been.*

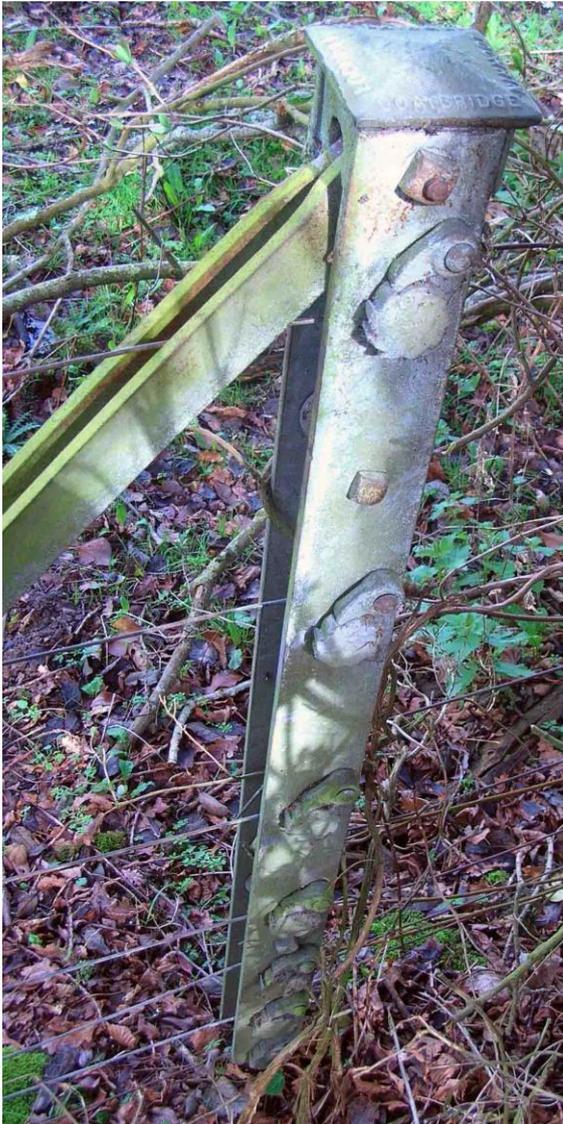
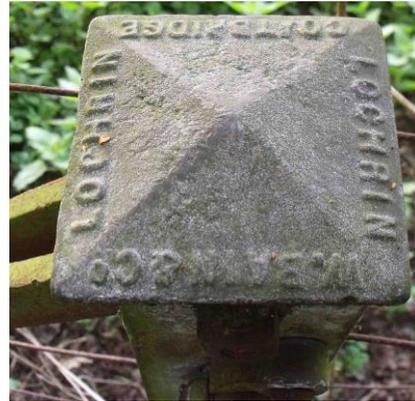
**Isle of Wight Central Railway Company - William Bain Fencing**

*IWCR used Wm. Bain to replace fencing – galvanising prolongs life.*

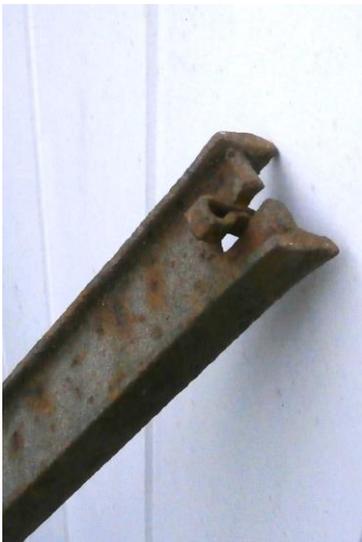
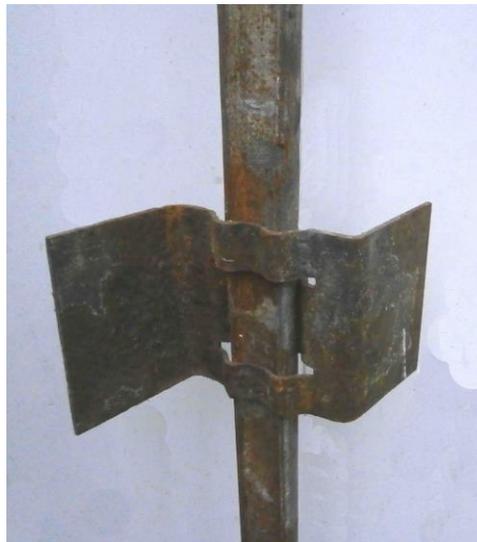
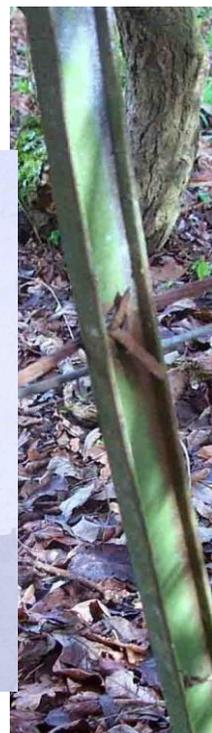
*Below centre: Post ground plate.*

*Below right: dropper wire fixing clip detail.*

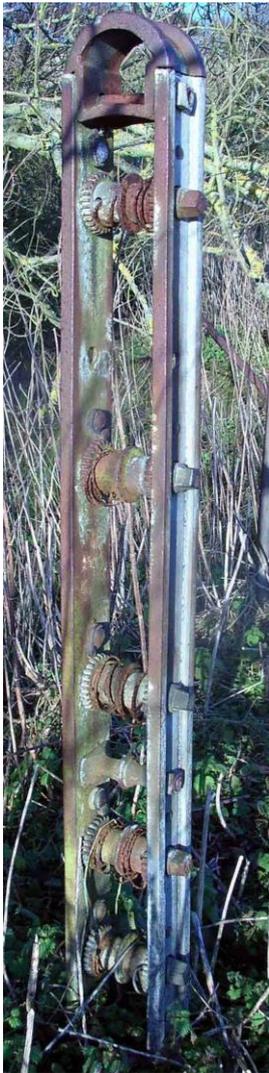
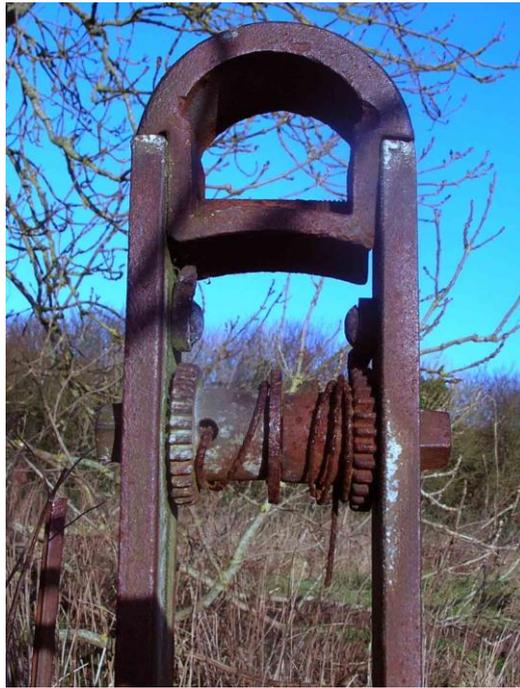
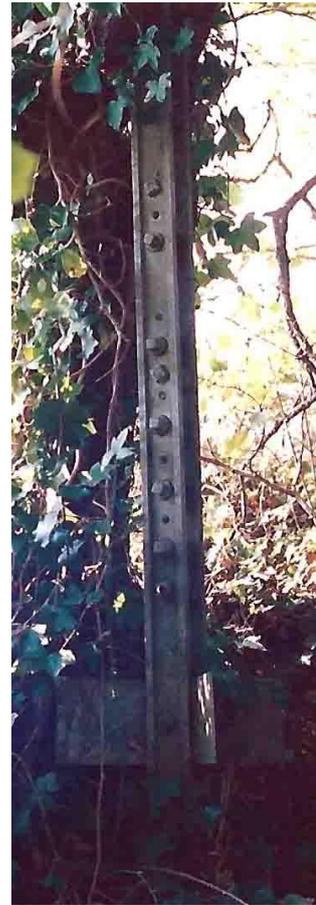
*Newport, Godshill & St Lawrence company built a good quality railway with well built stations and structures, at least on the Merstone to St Lawrence section. The fencing used galvanised posts, gates and heavy straining posts which still show little sign of deterioration a hundred and twenty years after installation. However, if they no longer serve a function they get removed like all other remains of the railway lines*

*Above left: a double straining post, the only double found.*

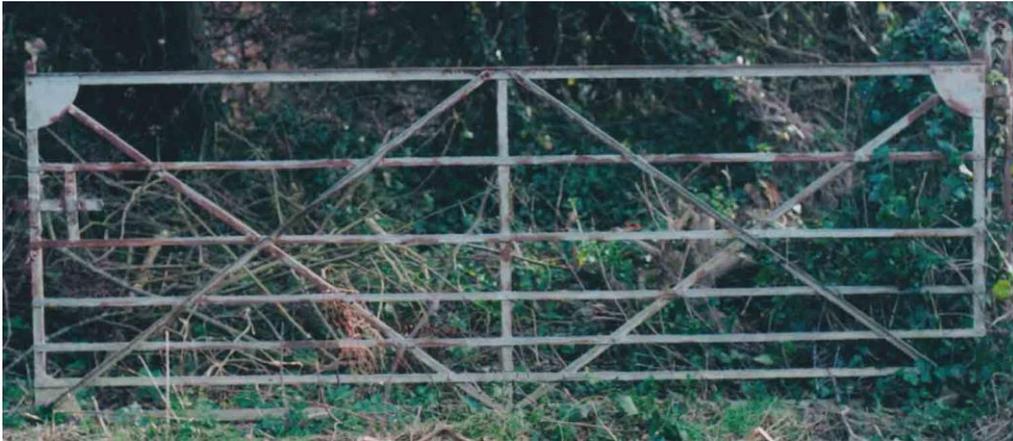
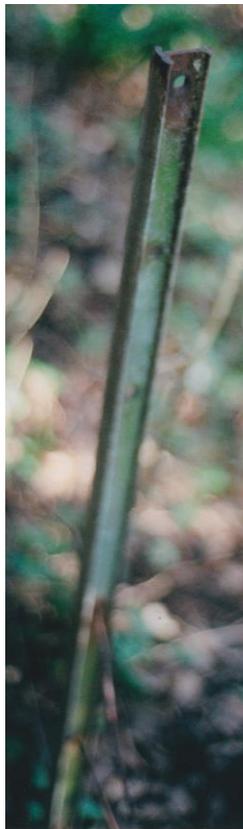
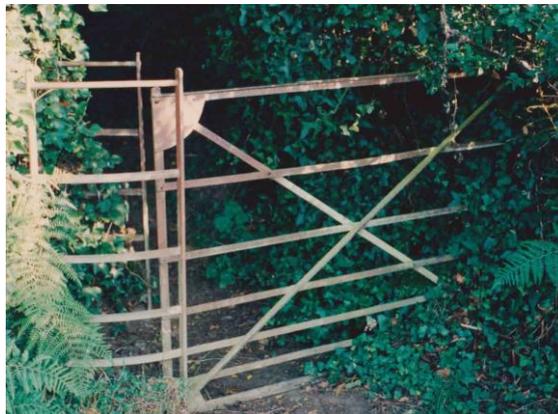
*Top: A BJB occupation crossing gate near Dean crossing.*

*Left: a dropper very similar to the surviving original FY&N type as it rested on the ground rather than being suspended like the Bain version does. It's also an 'L' shape section but unlike the FY&N these are galvanised and still survive although only ten years younger. Centre: A standard.*

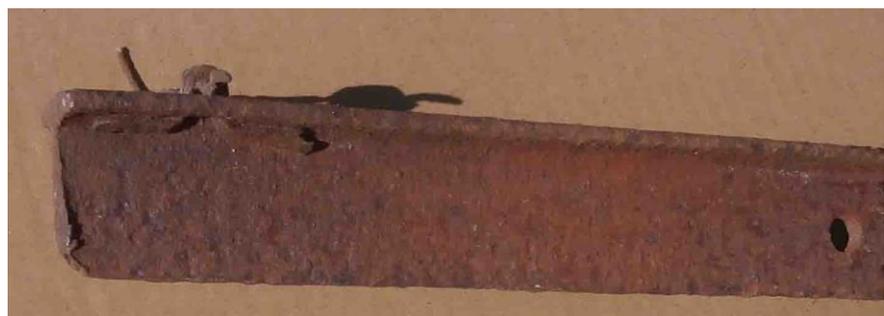
*Below: 'Tee' section post from the Ventnor section with the only barbed wire yet found on any line fixed with a clip – post unknown supplier.*

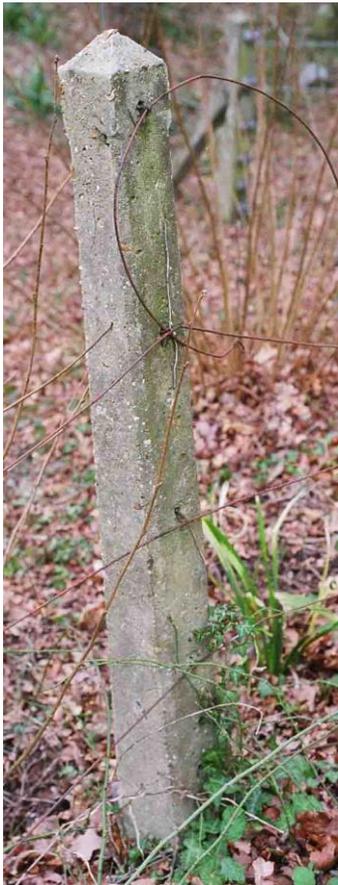
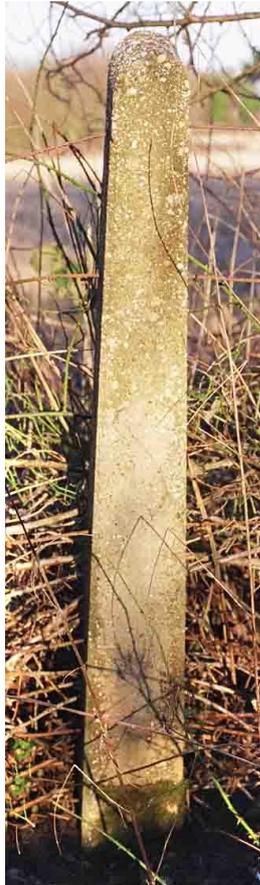
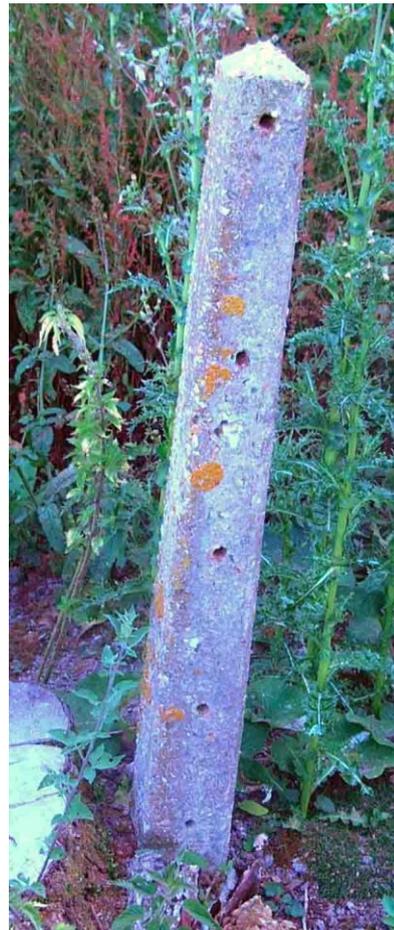
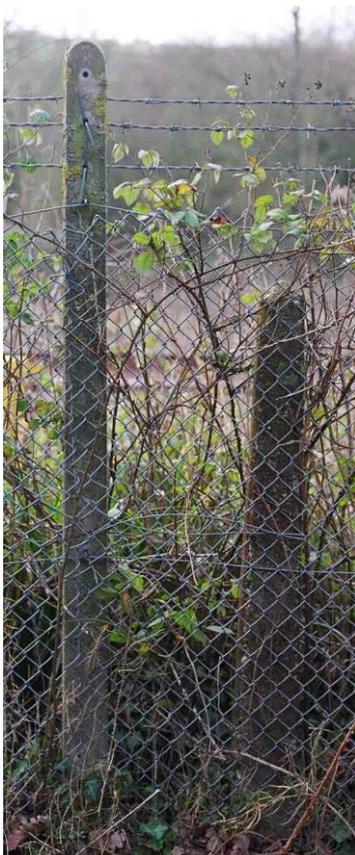
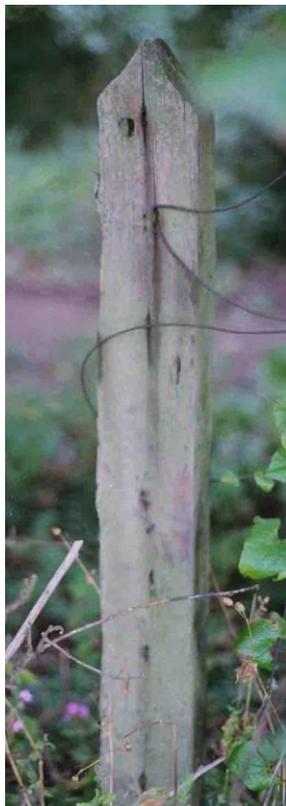
## Replacements - Wood & Concrete

*Ferro-concrete posts were being produced by the early 20<sup>th</sup> century and IWR & IWCR probably used them for fence replacement. Various styles can be found, but dating is uncertain.*
